Wonderwood Connector Bridge Post-Tensioning Tendons Investigations and Phase 1 Repair

Teddy Theryo, Ivan Lasa, Marcelino Aguirre, Daniel Rosa

- **Bridge No. 720677**
- Wonderwood Connector Bridge is located over the Inter-coastal Waterway on SR 166, north east of Jacksonville, FL
- The total bridge length is 3584' and 90'-9" wide deck consisted of 8 lines of prestressed concrete I girders.
- The focus of this presentation is the three-span continuous Post-tensioned spliced girder main span bridge of 197'-250'-197' (total length of 644')

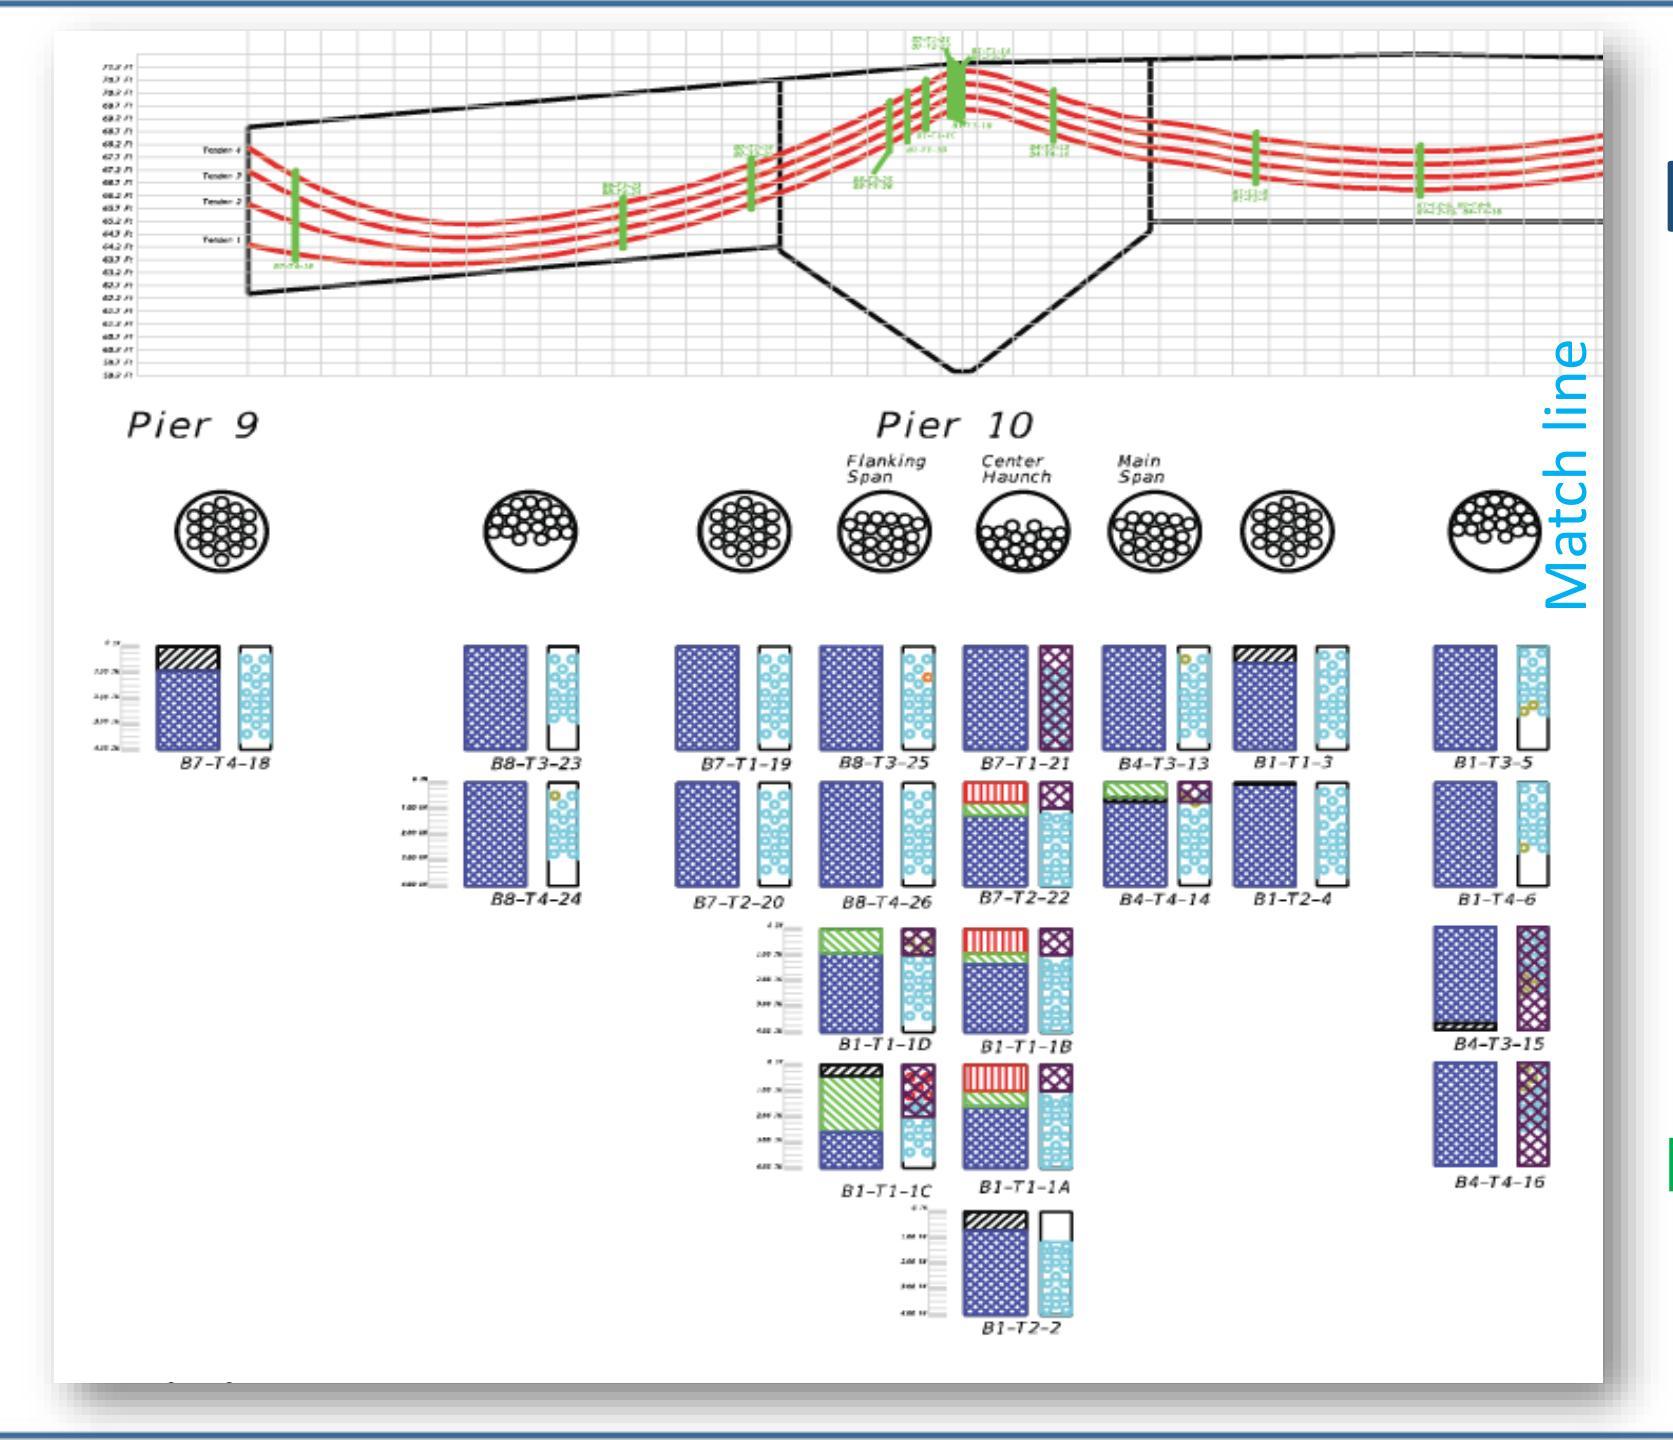
PT Tendons Investigations Legend Putty Grout Thick Black Material Soft and Chalky Grout Hard Grout Ducts Corroded Ducts Location of Strands 4999

Severe Strand CorrosionModerate Strand CorrosionMinor Surface Corrosion

Findings in graphical form Courtesy of D2 DSMO

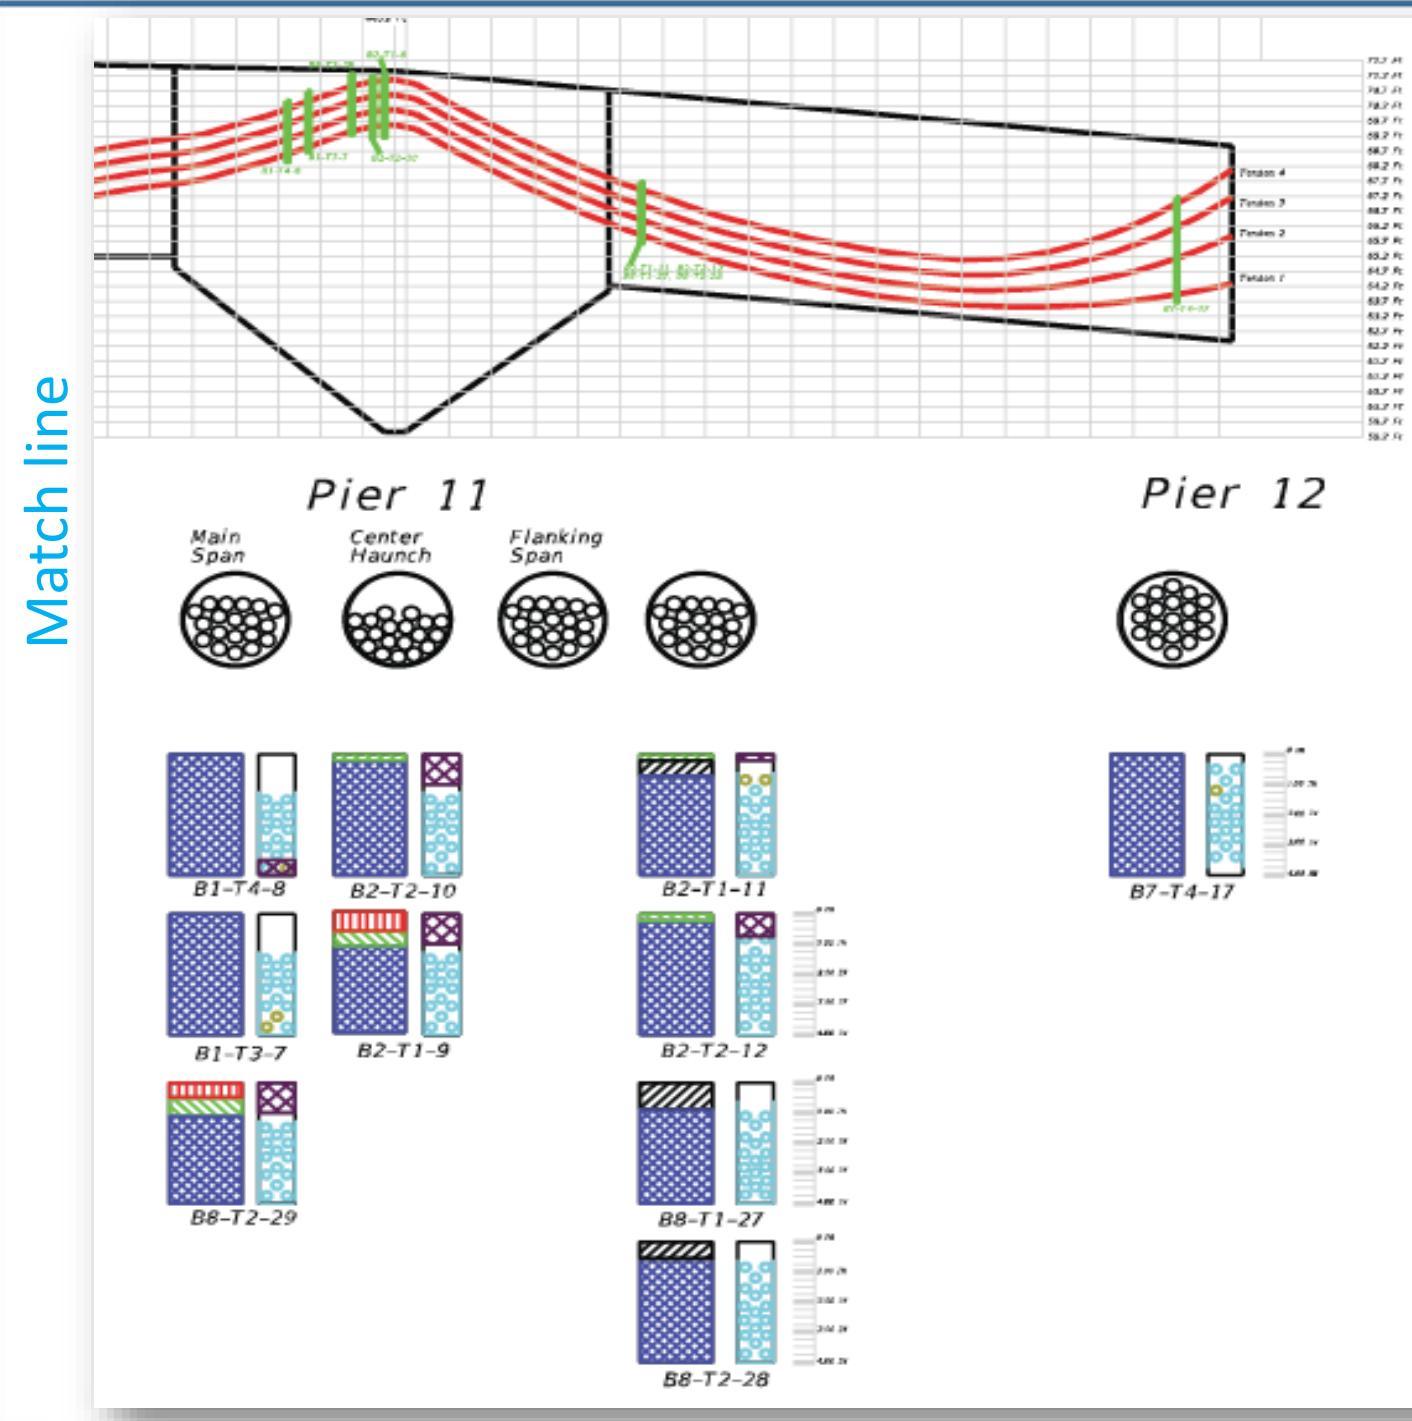
PT Tendons Investigations Legend Putty Grout Thick Black Material Soft and Chalky Grout Hard Grout Ducts Corroded Ducts Location of Strands مممه Severe Strand Corrosion 000 ₩ Moderate Strand Corrosion 9999 Minor Surface Corrosion

Findings in graphical form Courtesy of D2 DSMO

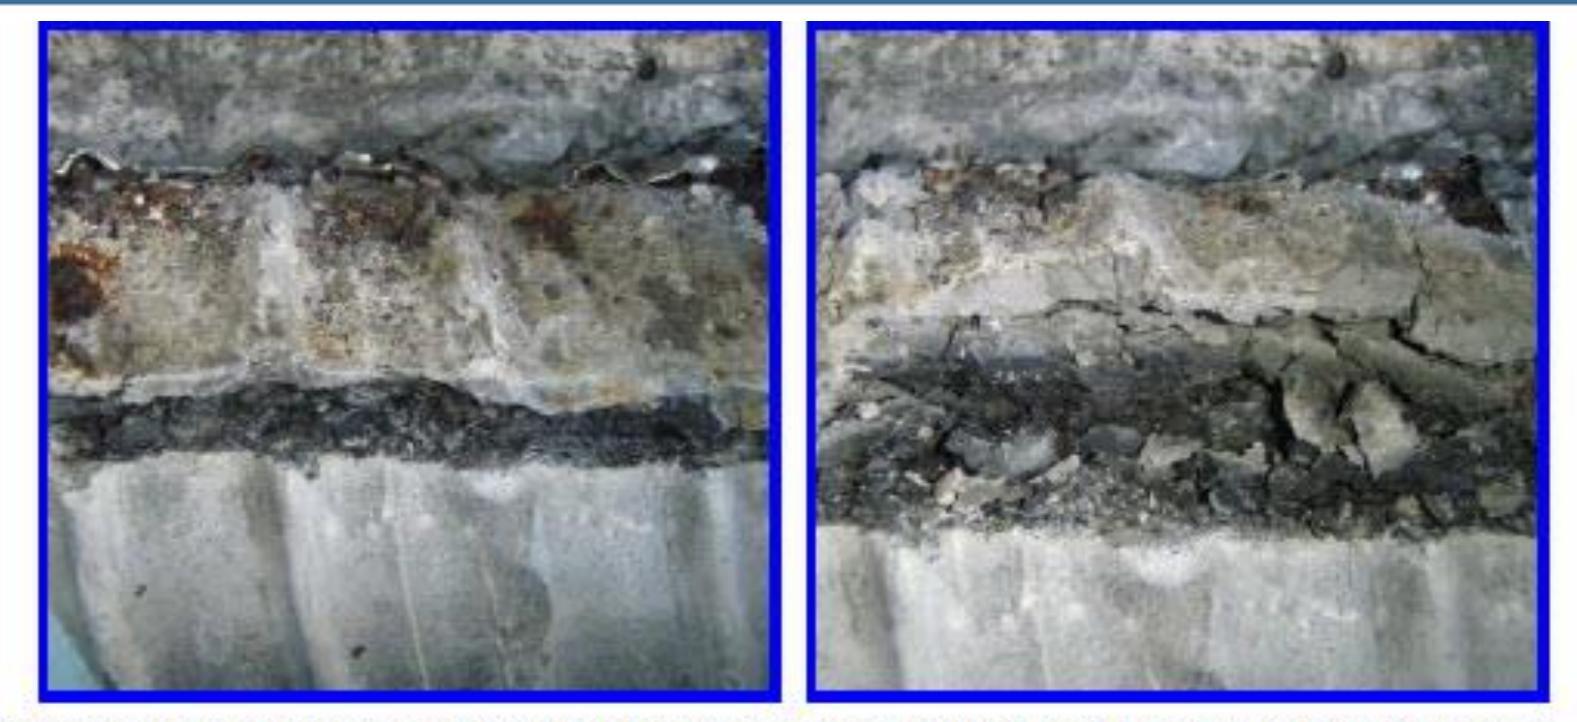
Tendon 2 in Girder 8 at Pier 11

Conditions while grout samples were being collected (note black material under the putty like grout).

Corrosion on the inside surface of the duct that was in contact with putty like grout (left photograph) and no corrosion on wires that were in good grout.

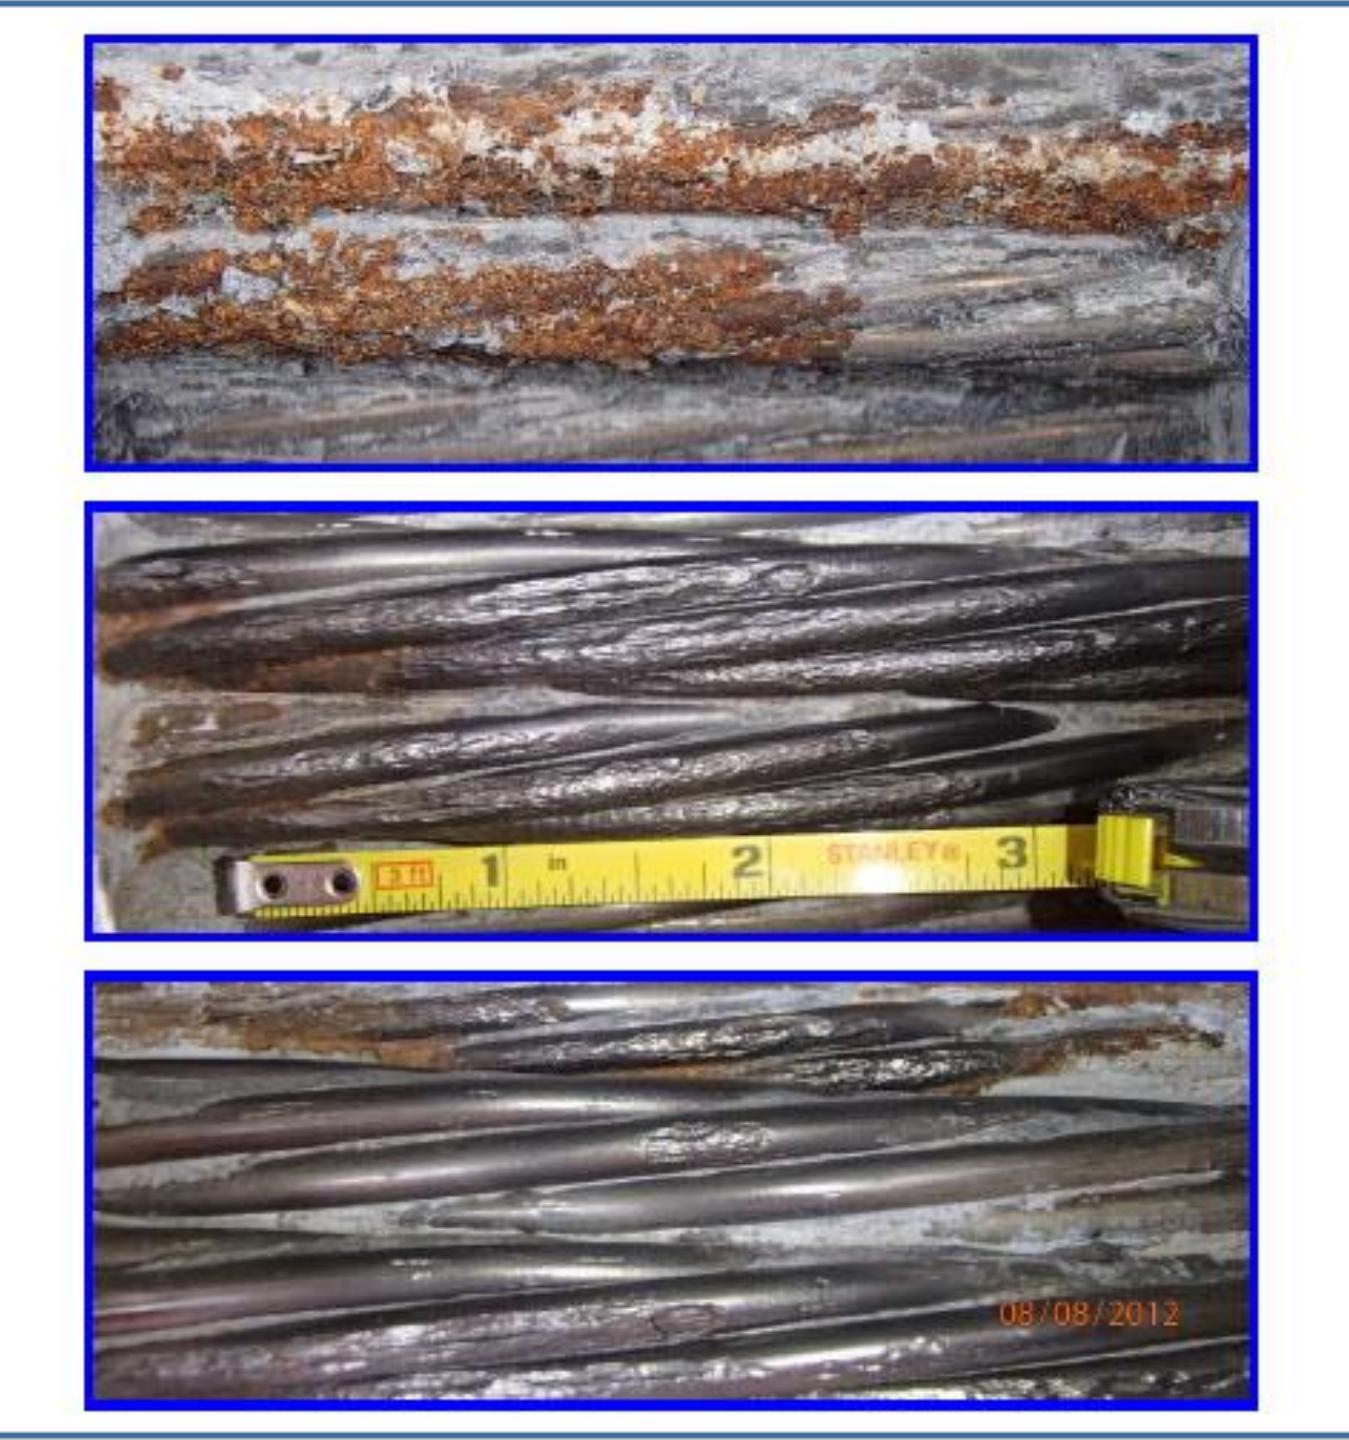
Strands with moderate corrosion and severe corrosion (before and after cleaning off corrosion products with a wire brush)

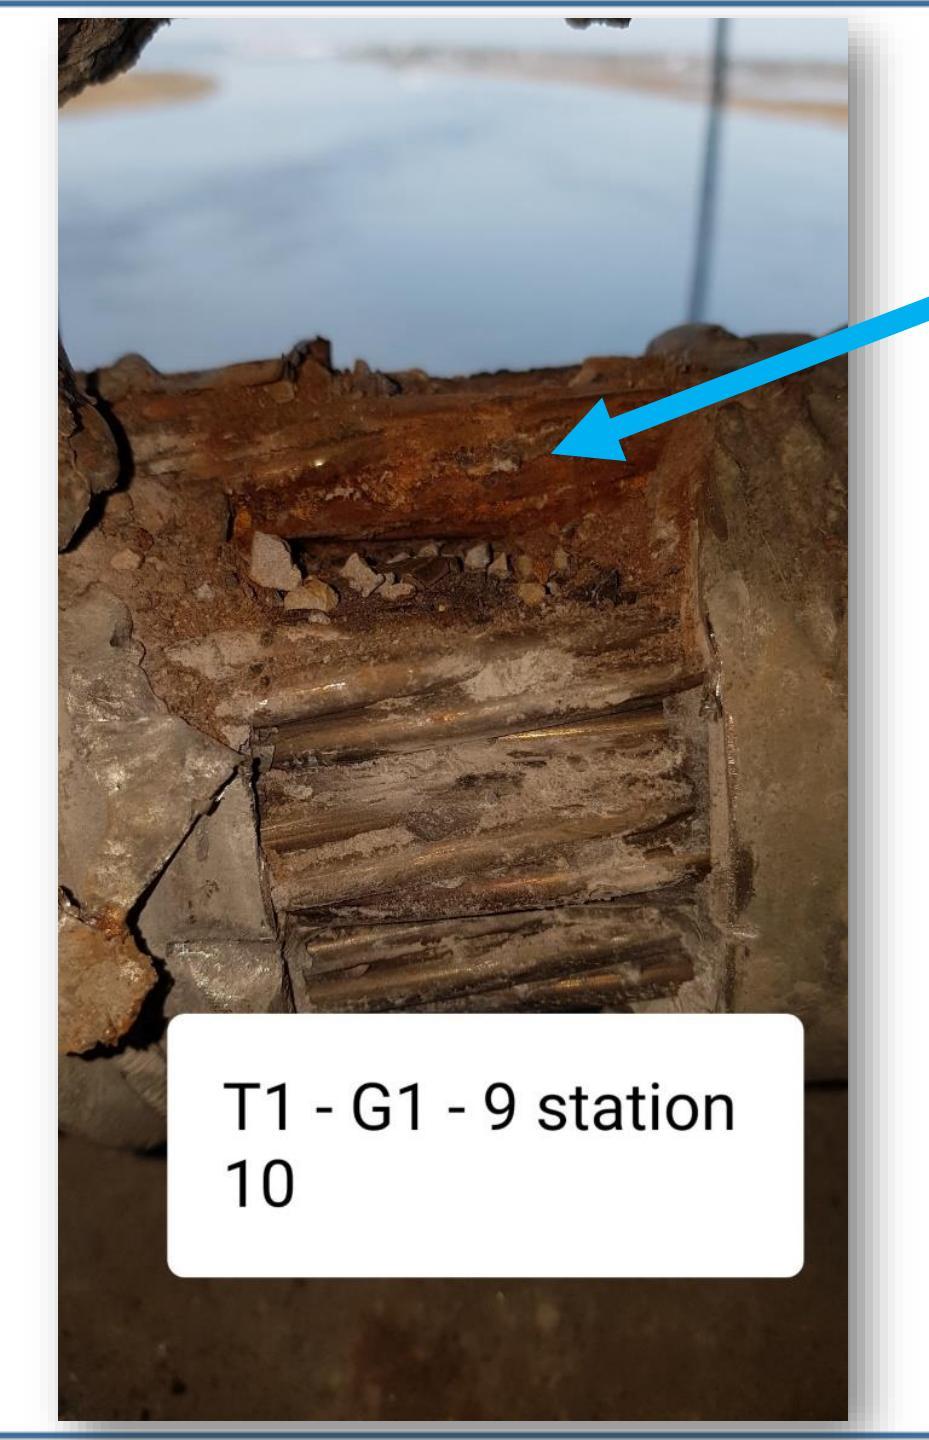
Failed corroded strand

Notes: The failed corroded strand was discovered during the repair when the contractor was trying to obtain grout sample for moisture test.

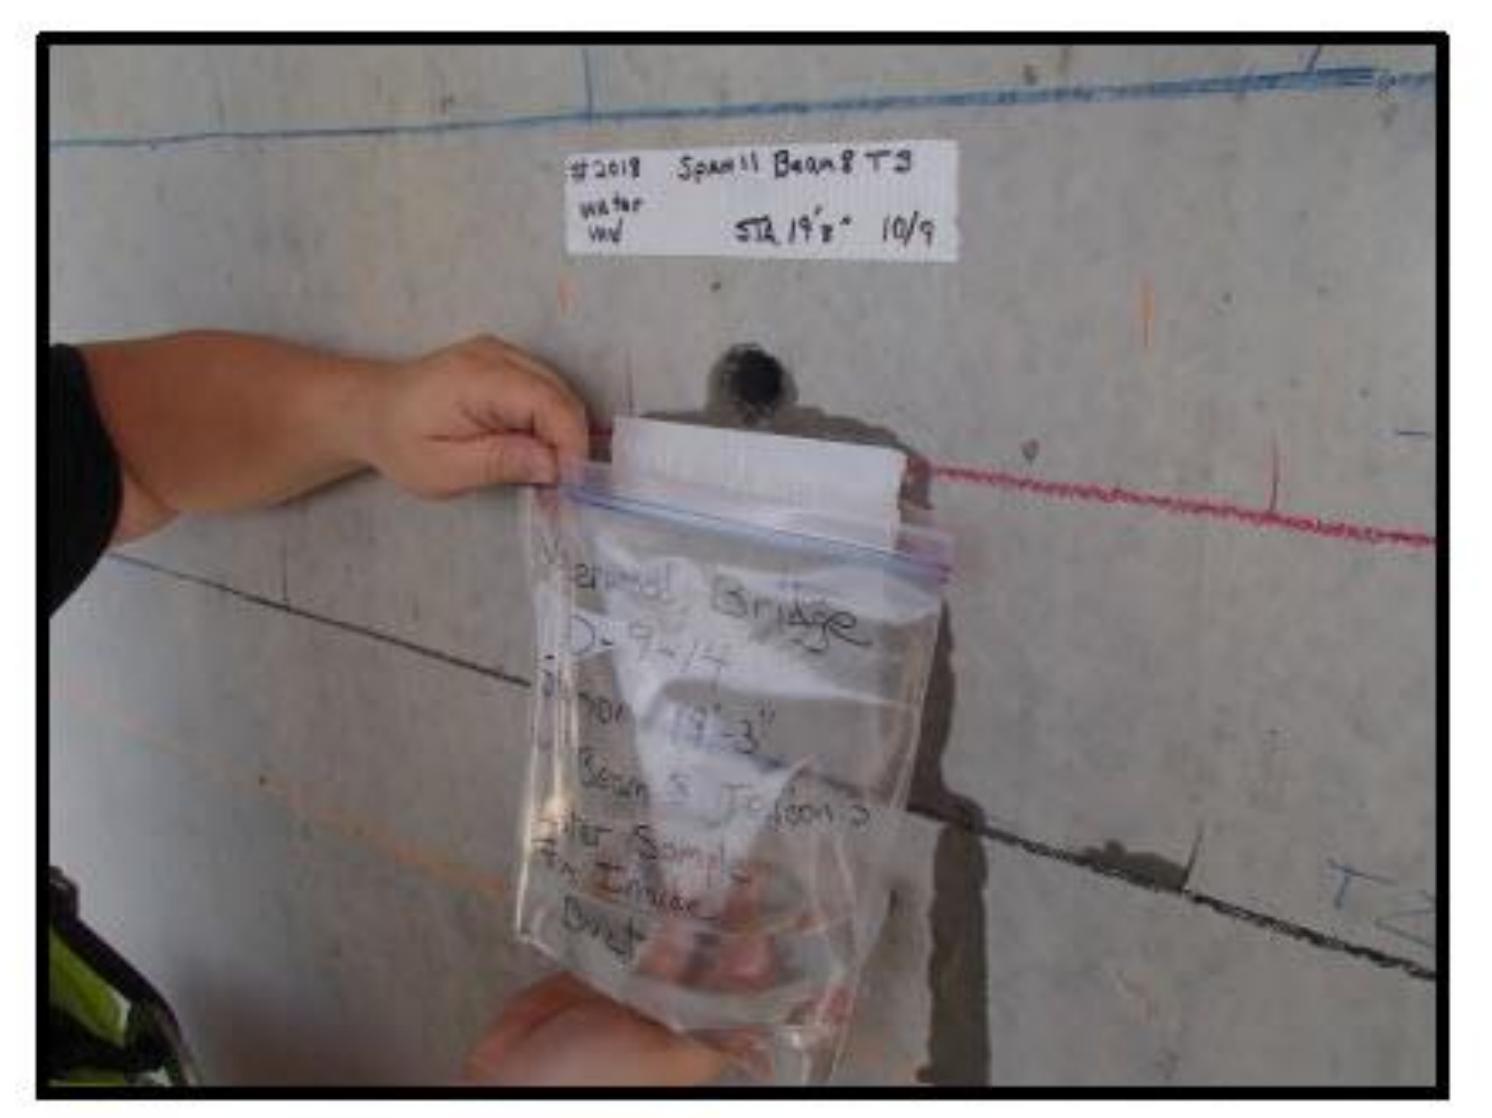
Figure 5A. Collection of a water sample at the drilled hole at NDT Station No. 19.

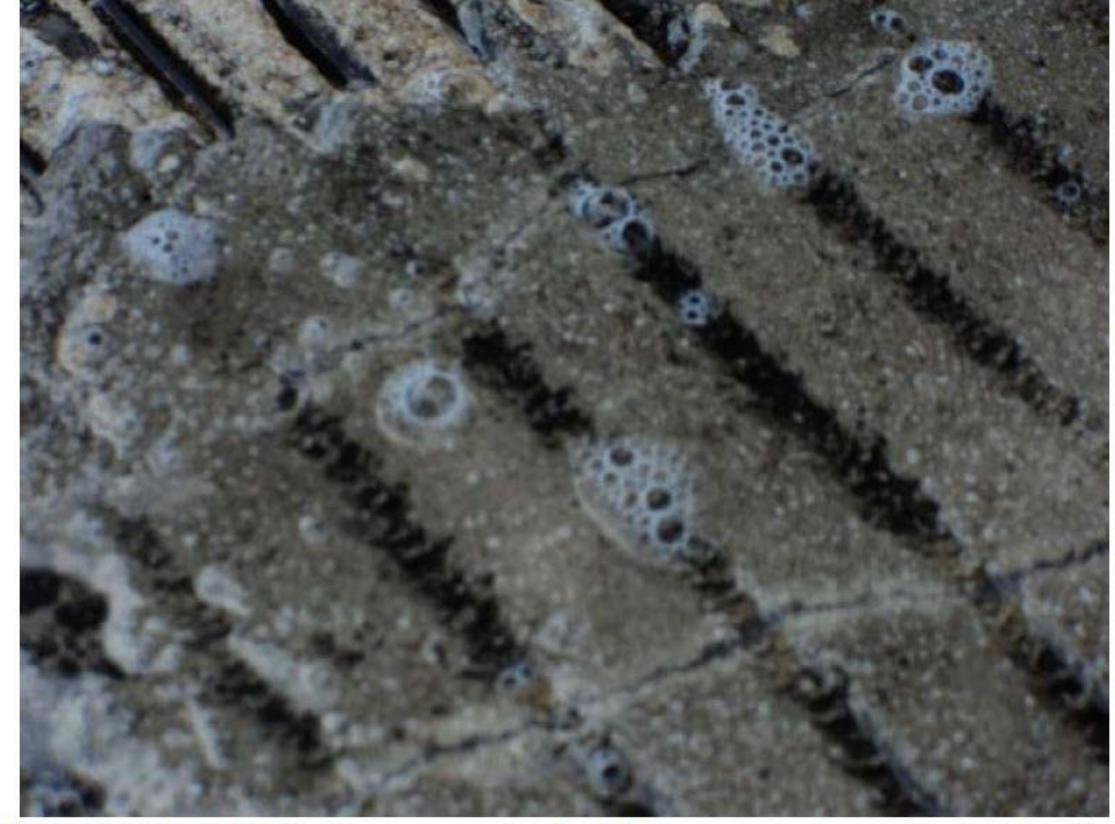
PHOTOGRAPH 8: Soapy water bubbles around cracks in the deck

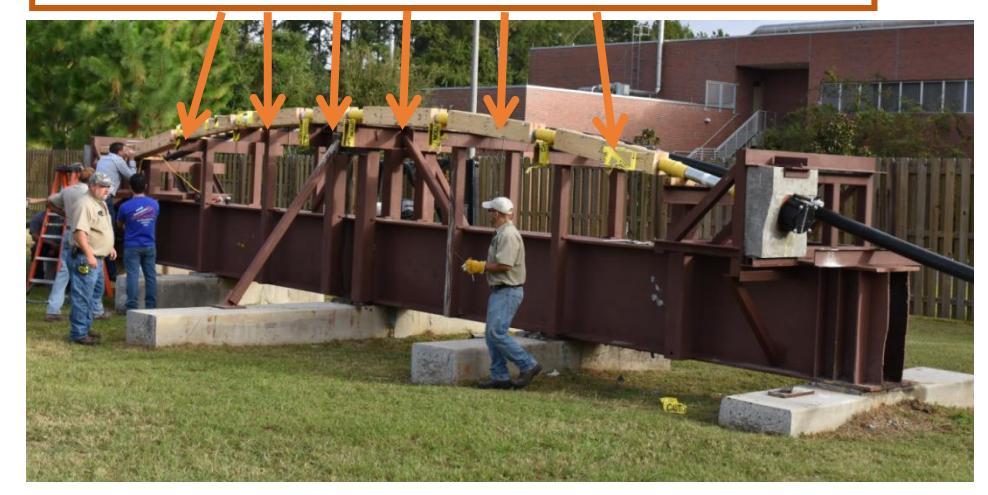
Results - Loose grout clogged outlet port

Results - Soft grout remained and water migration to hard grout locations

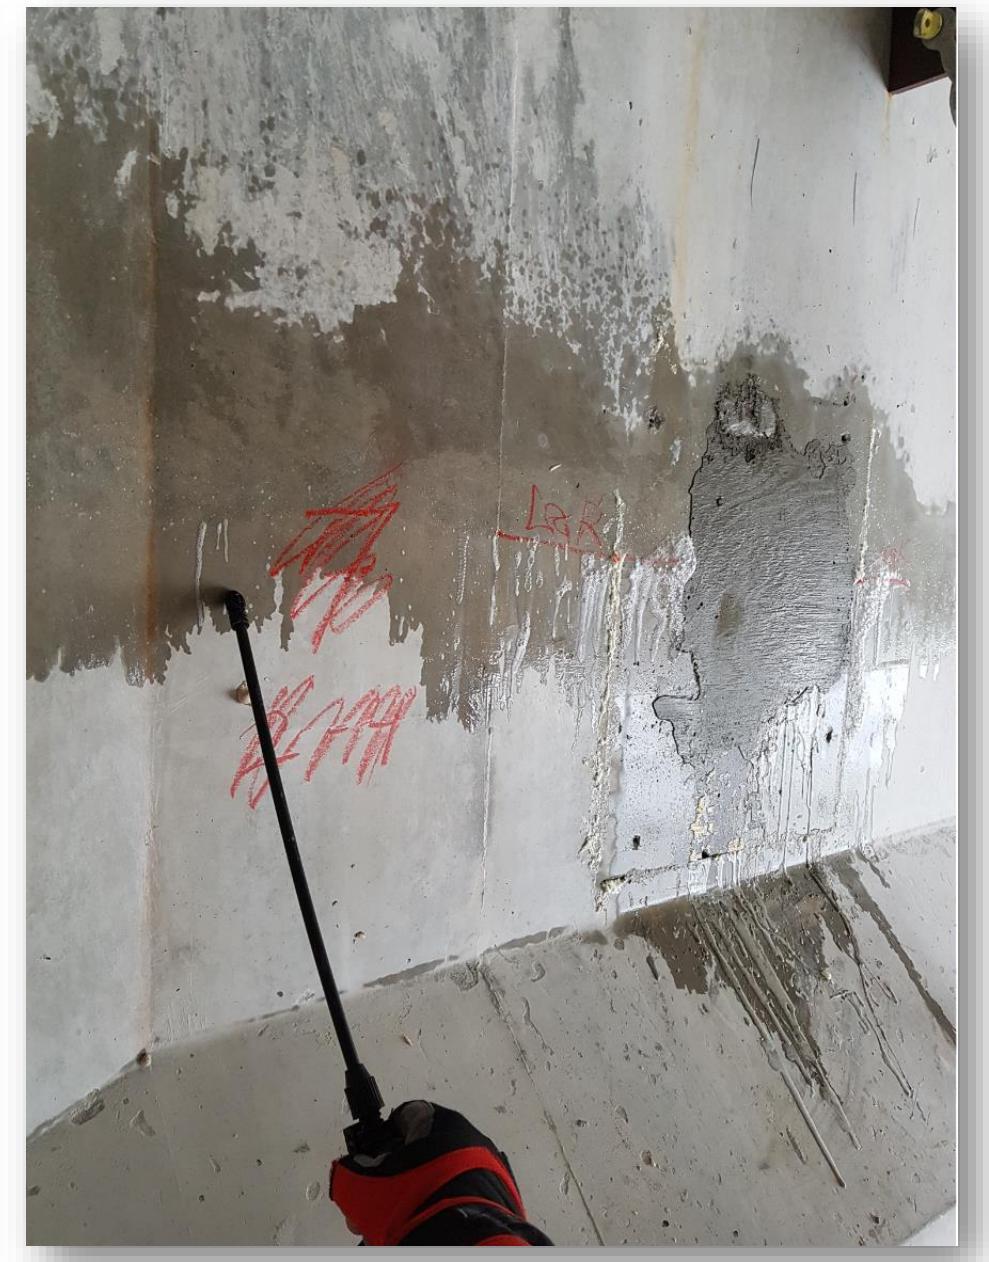
Major Leak Zones

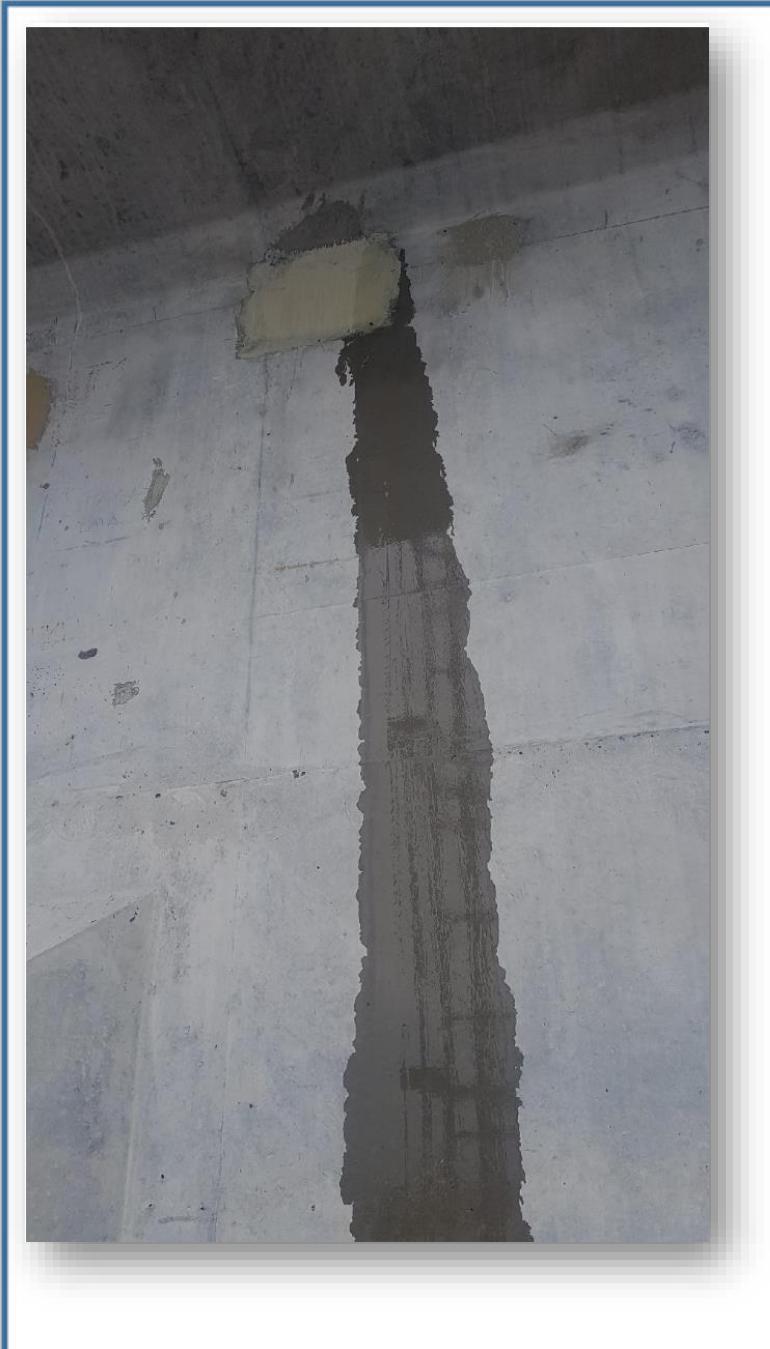
4 Cables Injected
8 cables In progress
(Repairing leak
locations)
