Structures Research Update

Will Potter

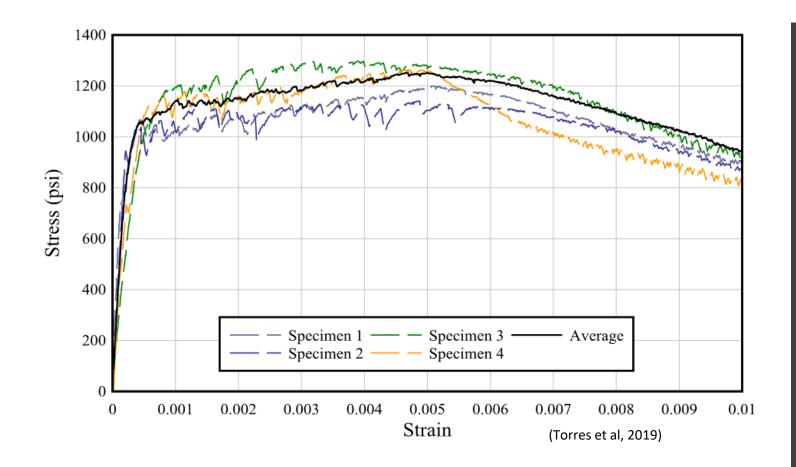
Direct Tension Test

- Basic Background
 - Fiber Reinforced (2%)
 - Portland Cement Product
 - w/cm ratio < 0.25
 - Sustained Tensile Strength > 0.72 ksi
 - Enhanced Durability
 - Flowable

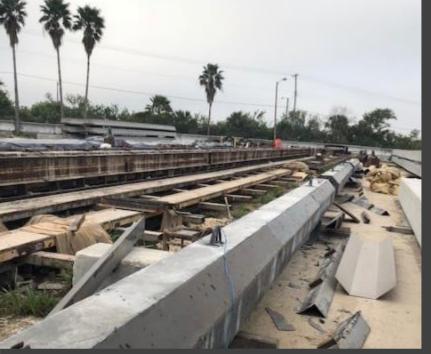
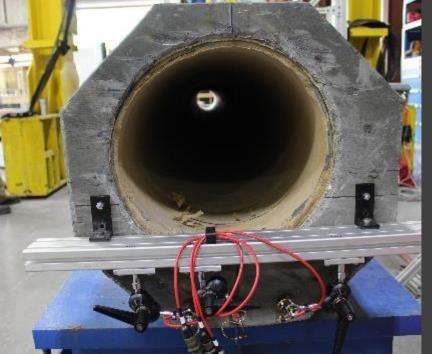
Dura-Stress Piling

- 18-inch Square Pile
- Compr. Strength (f'c) 23-24 ksi
- Direct Tension Test 1.2 ksi

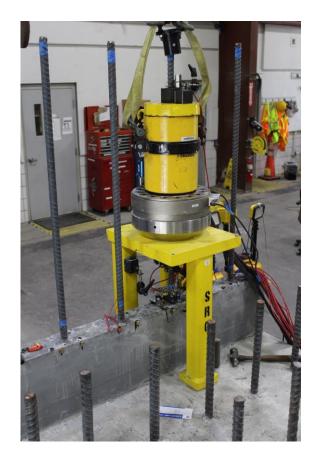
Test Parameters

- Bar Size: #8, #9, #10, #11
- Bar Strength: 60 ksi
- UHPC Strength: Less than 14 ksi target
- UHPC Fiber Content: 2% by volume
- 1.75" and 3.75" cover
- Various Bar Spacings

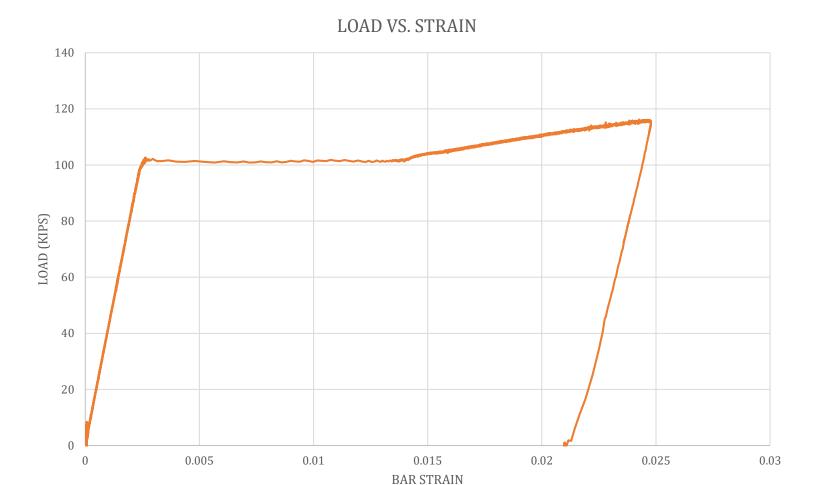
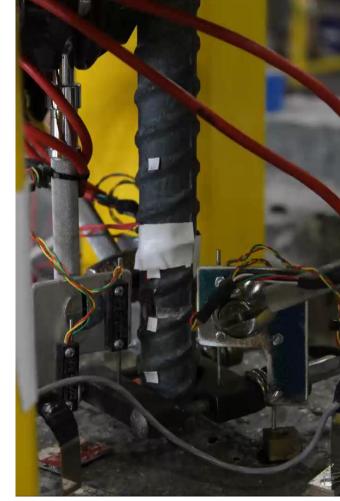
Break Modes

- 4 Different Modes
 - Side Splitting
 - UHPC Failure
 - Bar Yielding/Fracture
 - Side Splitting to Adjacent Bar

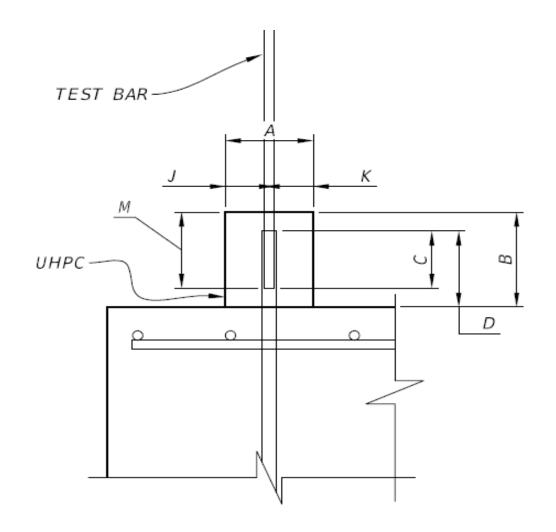
Preliminary Results

Required Embedment Length (M, D) in Terms of Bar Diameters							
		Bar Size					
		No. 8 (Per FHWA)	No. 9	No. 10	No. 11		
er	1.75 in	8	10	12	13		
Cove	3.75 in	8	8	8.6	10

Required Splice Length (C) in Terms of Bar Diameters								
		Bar Size						
		No. 8 (Per FHWA)	No. 9	No. 10	No. 11			
over	1.75 in	6	7.5	10	11			
CoV	3.75 in	6	6	6.6	8

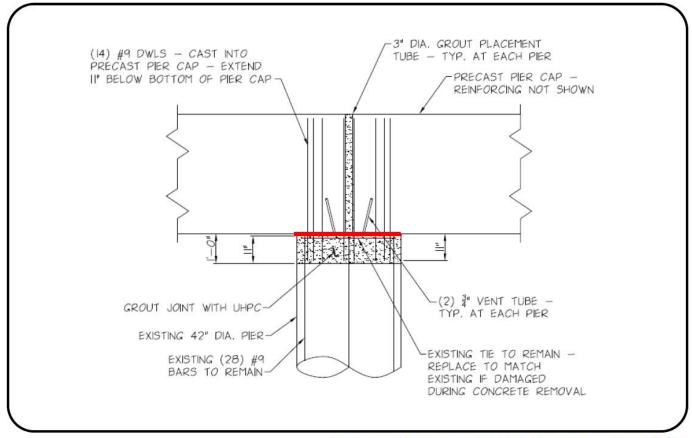
Hooper Road over US 17C in Union, New York
(Graybeal/FHWA)

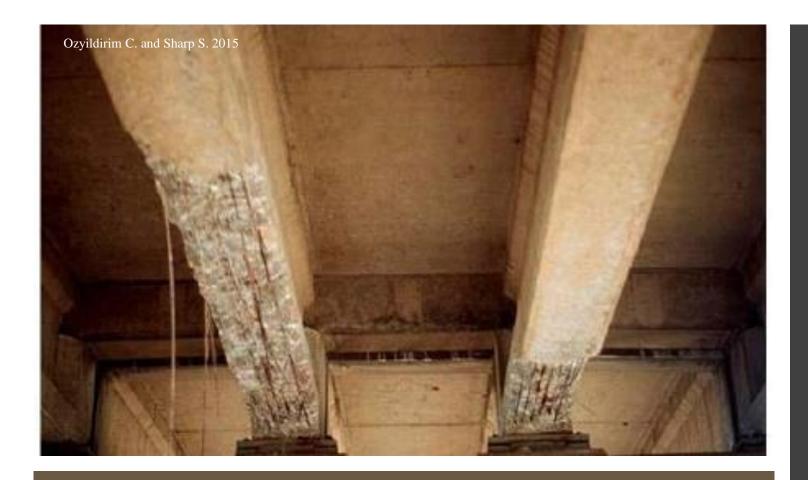
Stainless-Steel Prestressing Strand – Flexural Design

- Corrosion Resistant Duplex 2205
- Improve Durability of Pretensioned Girders
- Develop Flexural Design Criteria

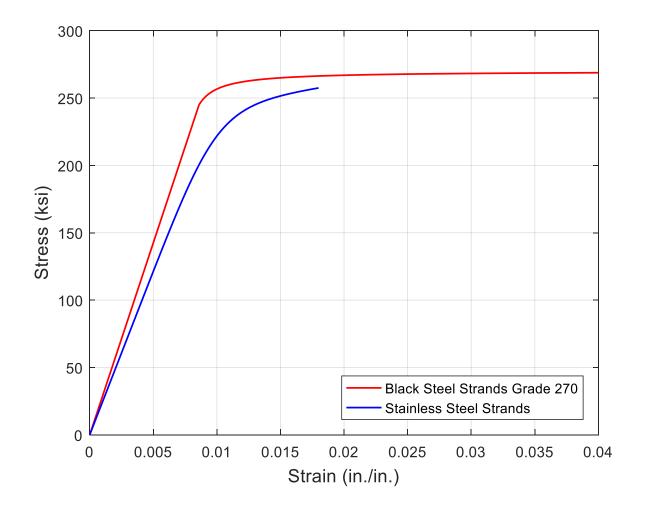
SS-Strand Mechanical Properties

- Elongation 1.2-1.9%
- Tensile Strength 240 ksi
- Sizes 0.5" & 0.6"
- 0.6" Area 0.23 in²
- Elastic Modulus 24,400 ksi

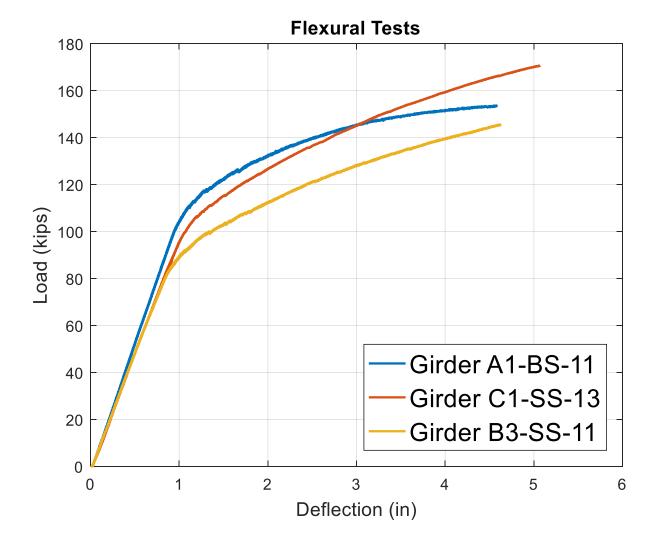
Initial Flexure Tests (No Deck)

- 4-pt bending
- Compression failure reached in all 3 Girders
- B3 and C2 bottom layer tensile strain, 0.0158 & 0.0138

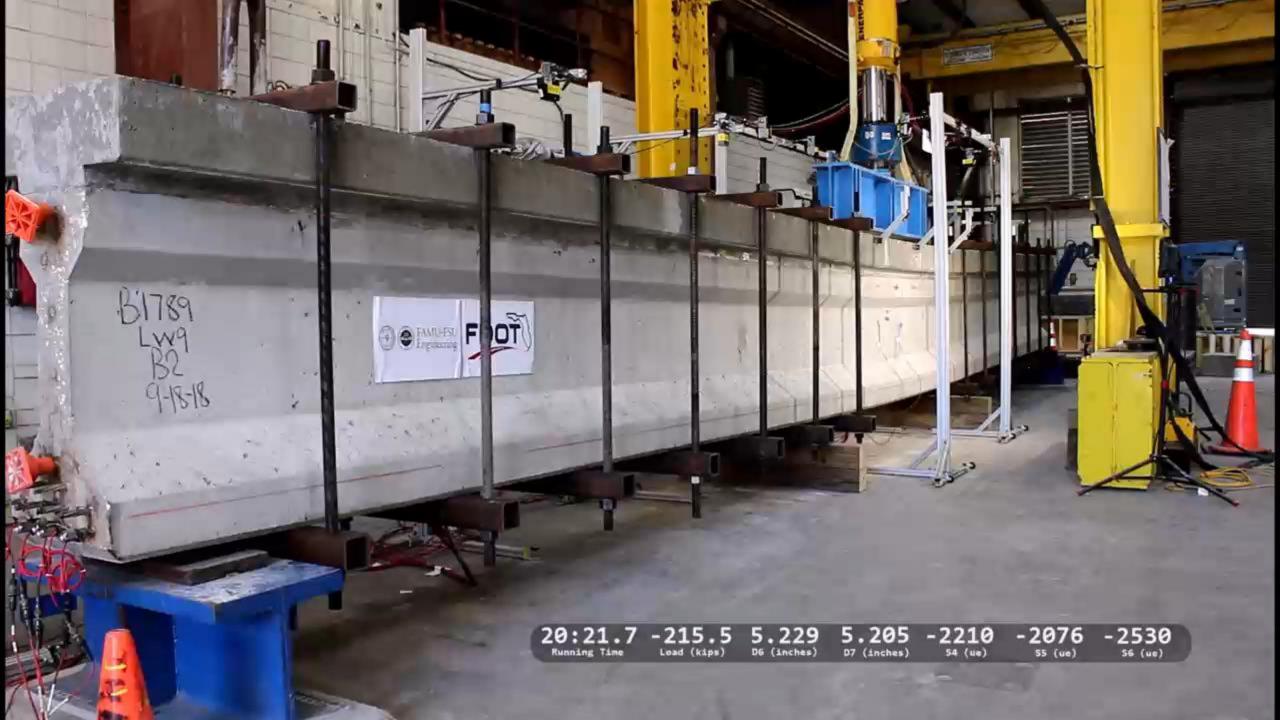
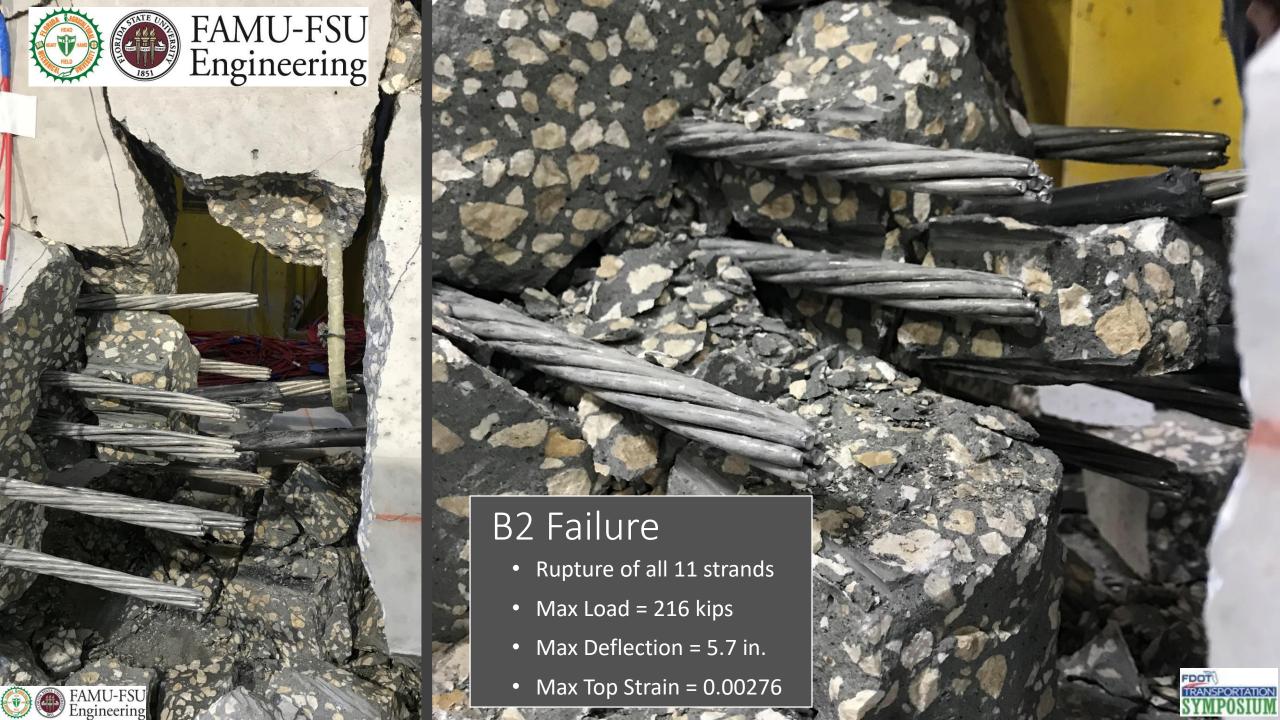
Decked Flexural Tests

- Achieve strand rupture
- Specimen B2 and C2 has GFRP shear reinforcement
- Added external clamps to prevent possibility of shear failure

- B2 & C2 both failed with strand rupture
- A3 was stopped just prior to failure (compression)

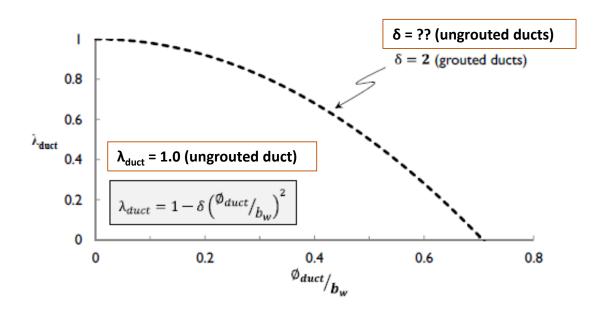
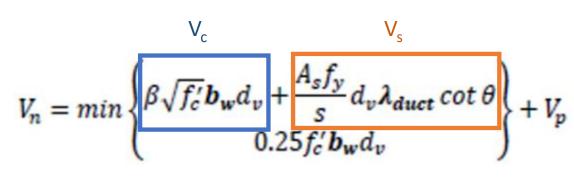
Reduce b_w to account for ungrouted duct

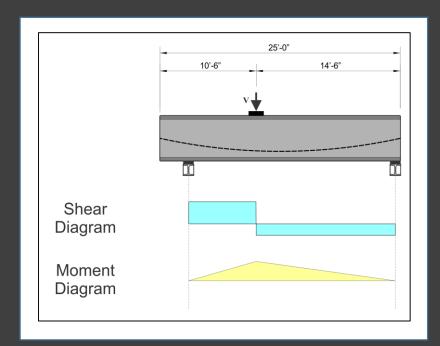
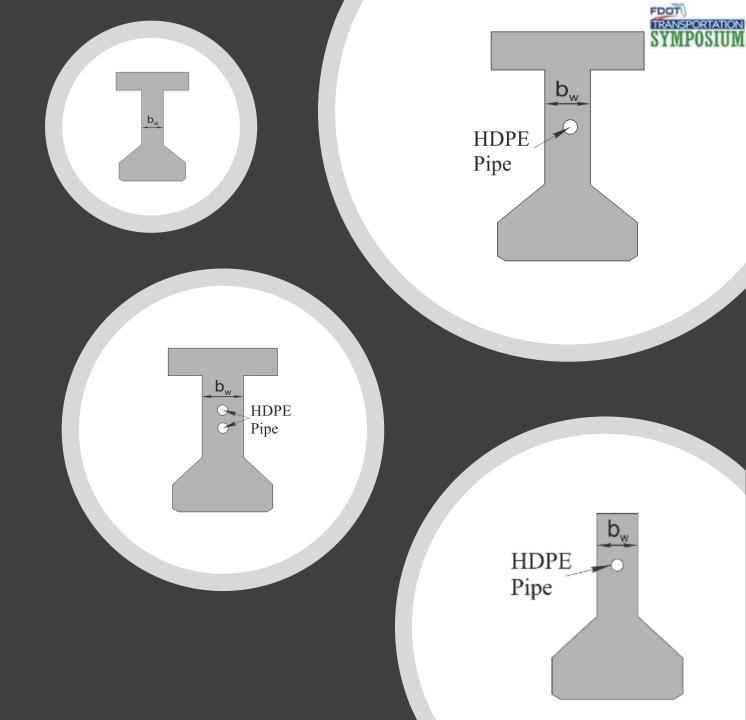
Initial Testing Phase

- Evaluation of Variables
 - Flange Boundary Conditions
 - Duct Diameter/Web Width Ratio
 - AASHTO increased to 0.54
 - 0.3-0.6 tested
 - Number of Ducts

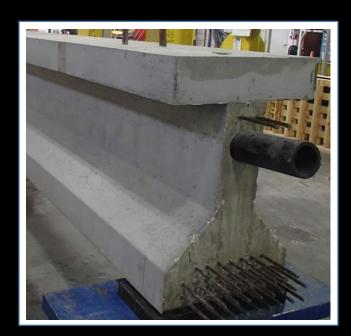
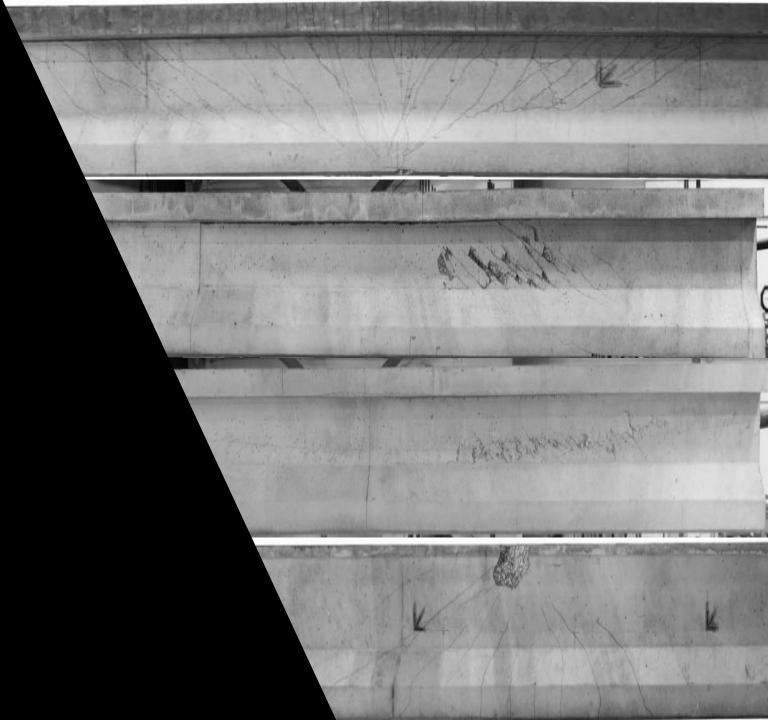
Initial Testing Phase

- Full-Scale Specimens
- Multiple Tendons
- Grouted vs. Empty
- Splice Region
- Negative Bending

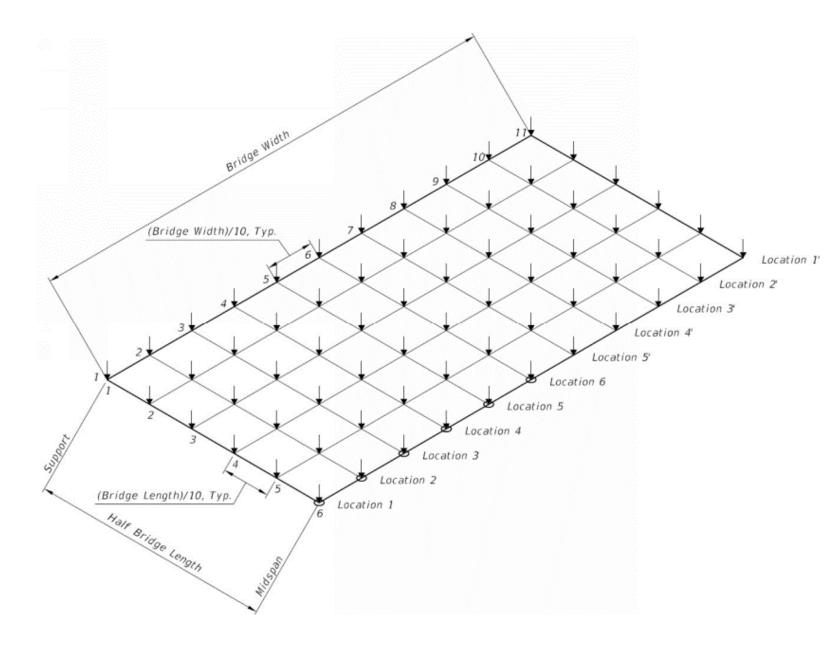
SALOD

- Based on 7 FEA models
- Aspect Ratio 0.5 to 3.0
- Interpolation Influence Surfaces
- Computes Effective Width
- Traditionally a "Black Box"

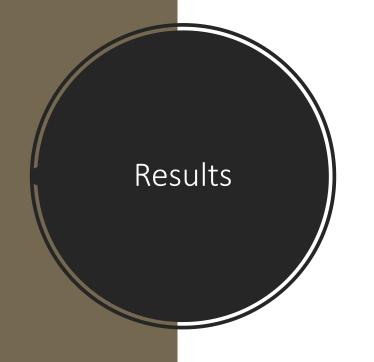
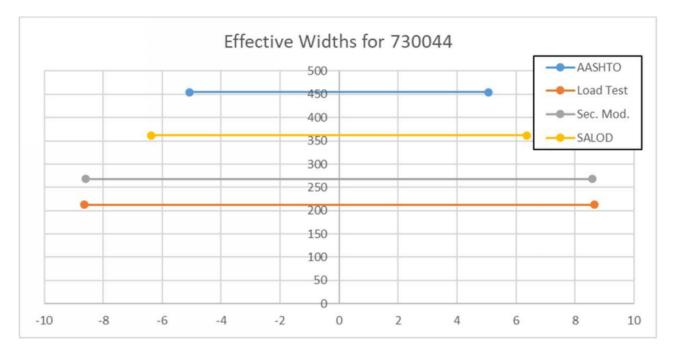
- SALOD is generally less conservative than AASHTO
- Only practical within the formulated aspect ratios
- Using SALOD methodology is the most effective way to improve load ratings
- Conservative when compared to load test results

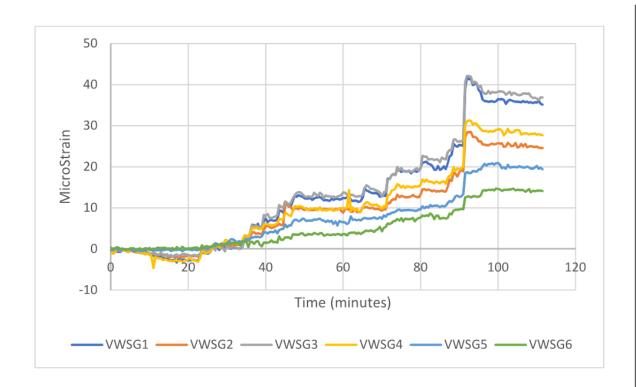
Force (kip)		
	Based on Maximum Individual Gage	Based on Overall Average Across Width	
After Step 1	-33.1	-12.0	
After Step 13	140.7	90.0	
All Strands Cut	411.2	267.9

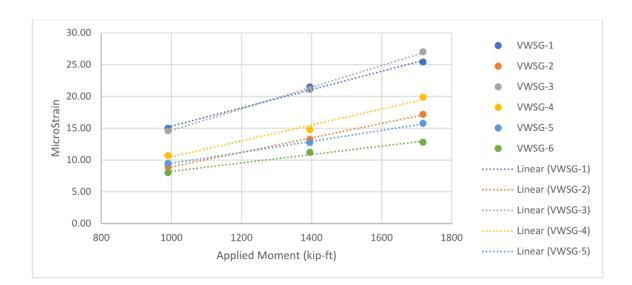
Truck Load Case	Applied Moment (kip-ft)	Predicted MicroStrain
Empty	990.2	14.3
Half Load (4 Blocks)	1394.9	20.1
Full Load (7 Blocks)	1717.8	24.8

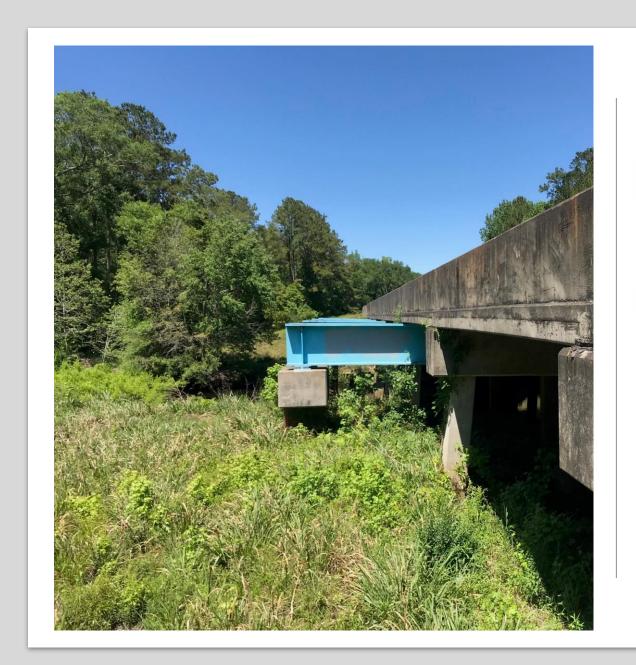
Bridge Load Testing

- Precast Pretensioned Panel Bridge (constructed 1977)
- Continuous for Live Load (??)
- 8 Spans (26-ft each)
- 46'-3" Width (2-12' Lanes)
- Depth 11.75" (7.5" precast panel 4.25" topping)
- Crutch Bents added in 2003
- Condition is Good
- Emergency Vehicle Load Rating (EV3)

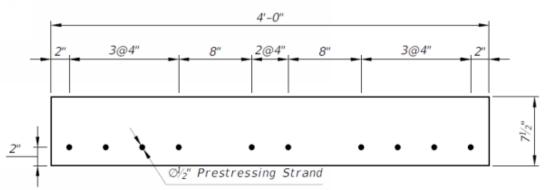
(a) Interior Beam

(b) Exterior Beam

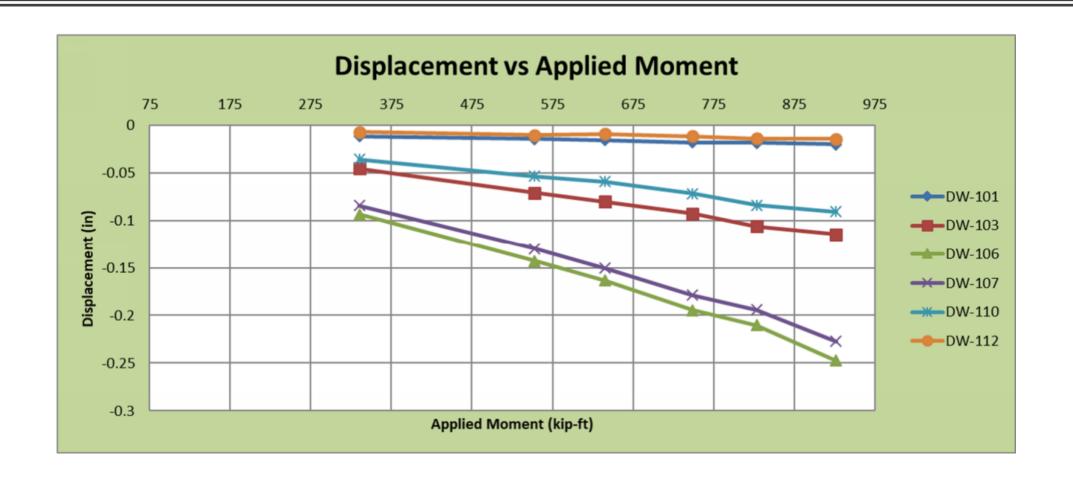
Linearity Check

Linear response (strain and displacement) for both monitored spans
