Wonderwood Connector Bridge Post-Tensioning Tendons Investigations and Phase 1 Repair

Teddy Theryo, Ivan Lasa, Marcelino Aguirre, Daniel Rosa

- **Bridge No. 720677**
- Wonderwood Connector Bridge is located over the Inter-coastal Waterway on SR 166, north east of Jacksonville, FL
- The total bridge length is 3584' and 90'-9" wide deck consisted of 8 lines of prestressed concrete I girders.
- The focus of this presentation is the three-span continuous Post-tensioned spliced girder main span bridge of 197'-250'-197' (total length of 644')

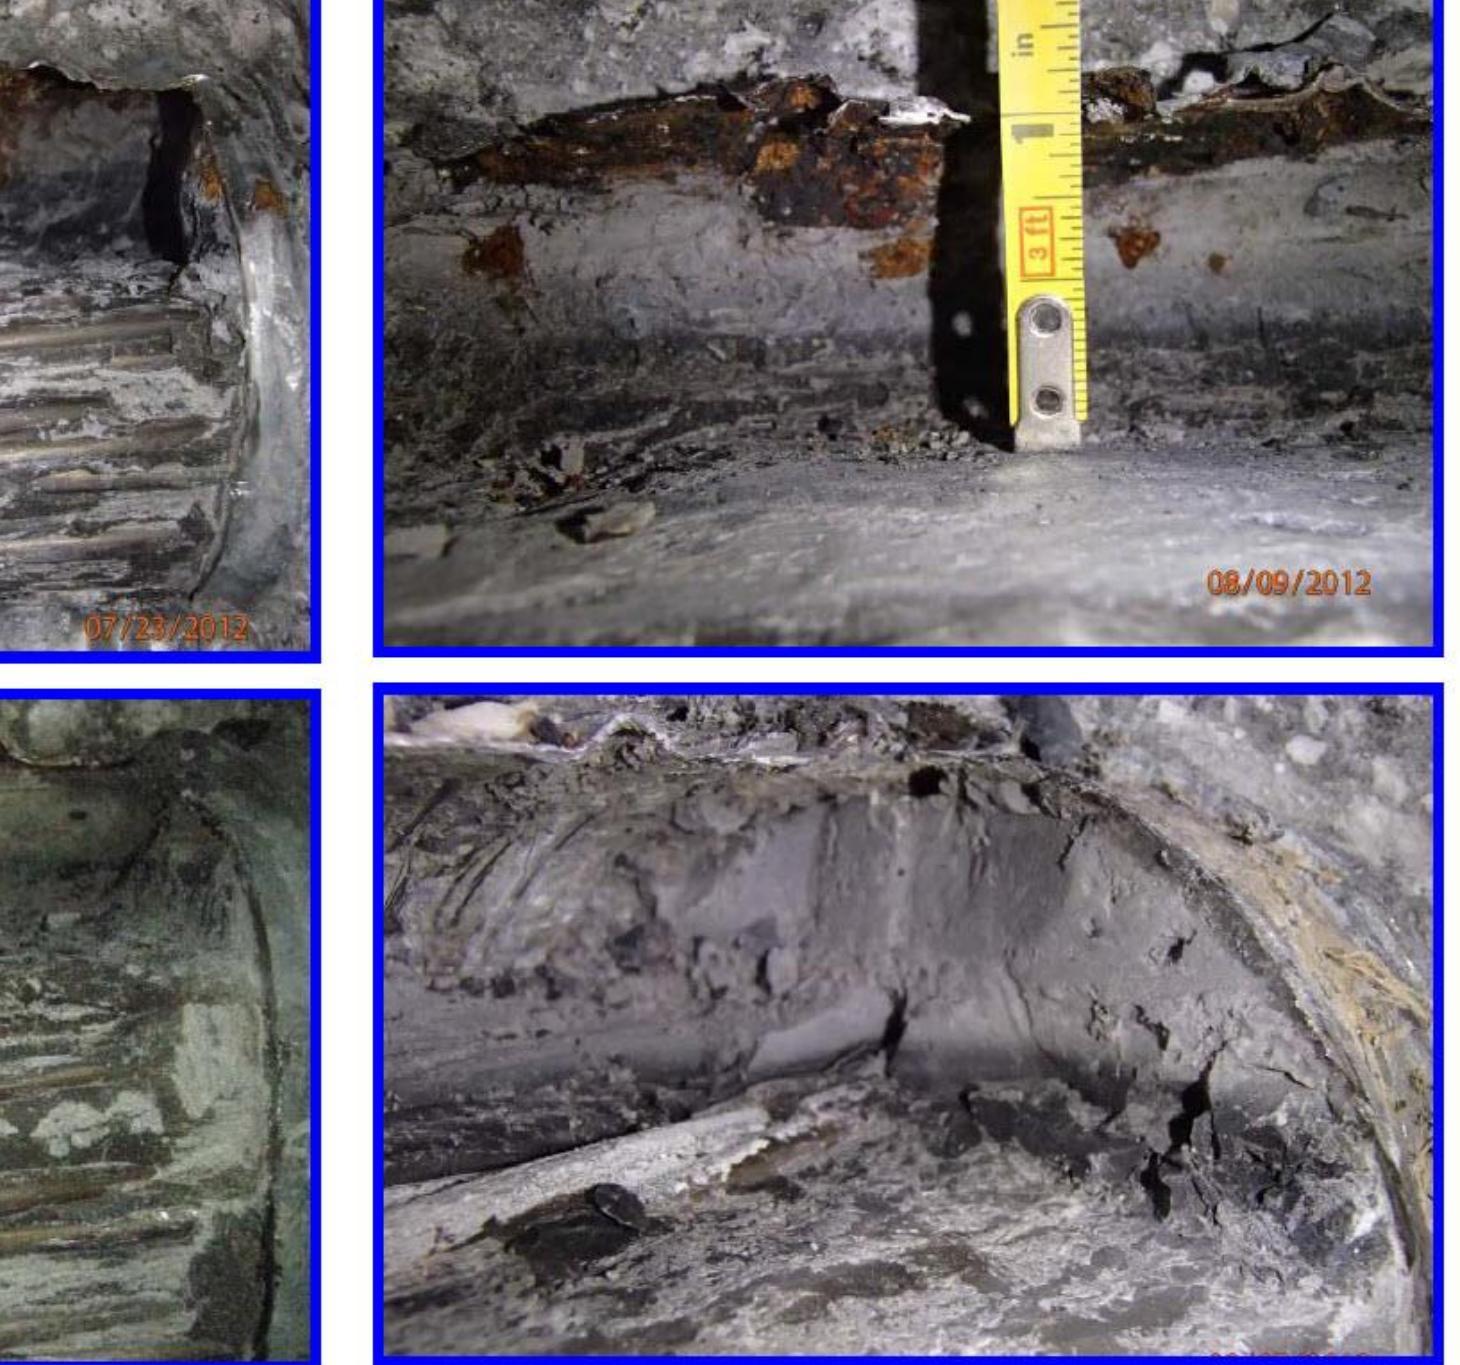
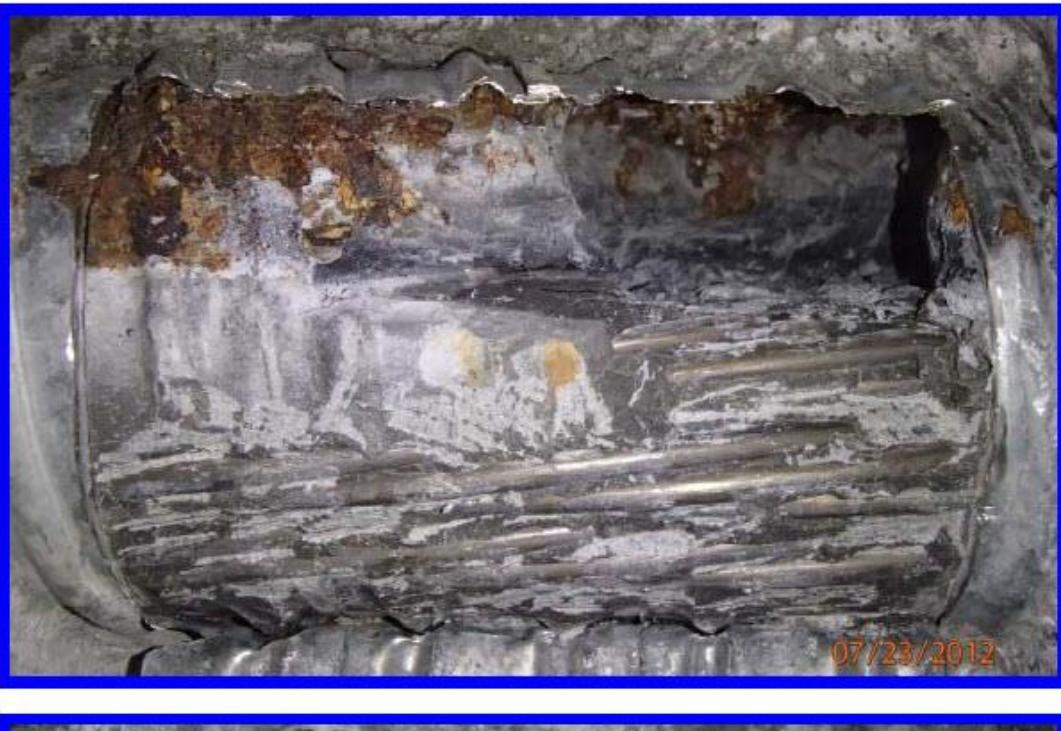
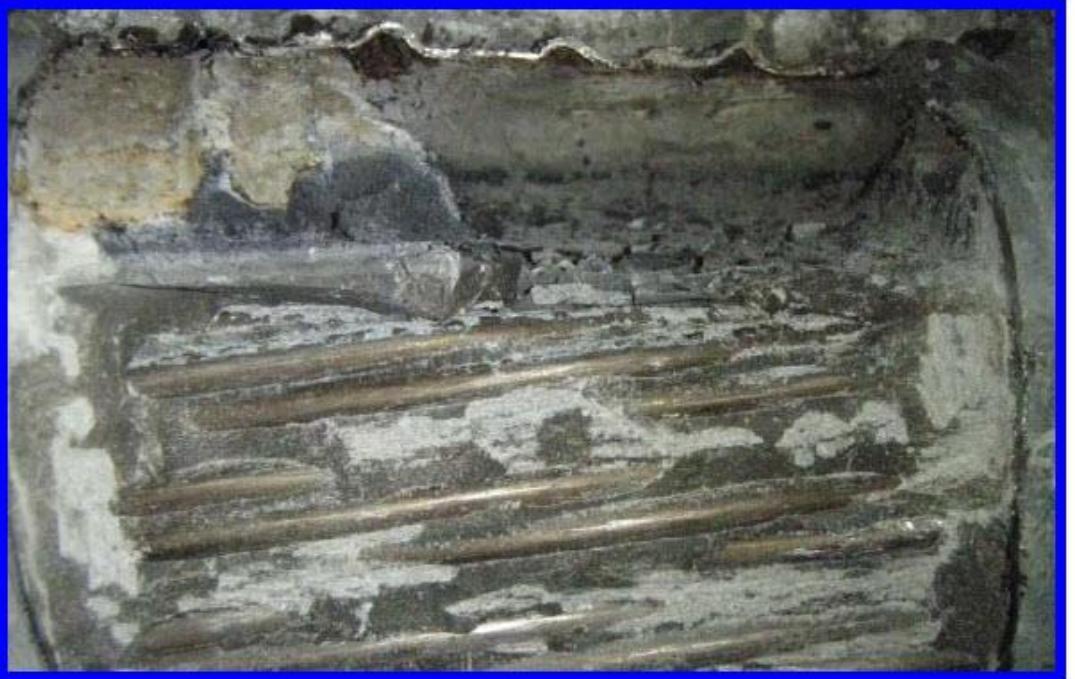
Strands with moderate corrosion and severe corrosion (before and after cleaning off corrosion products with a wire brush)

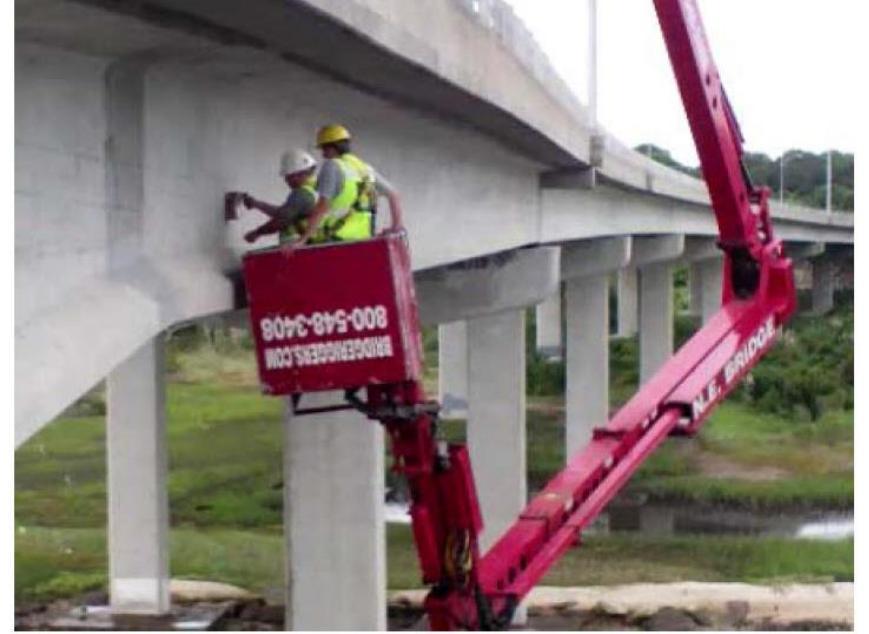
PHOTOGRAPH 1: Passing a radar antenna over a web tendon

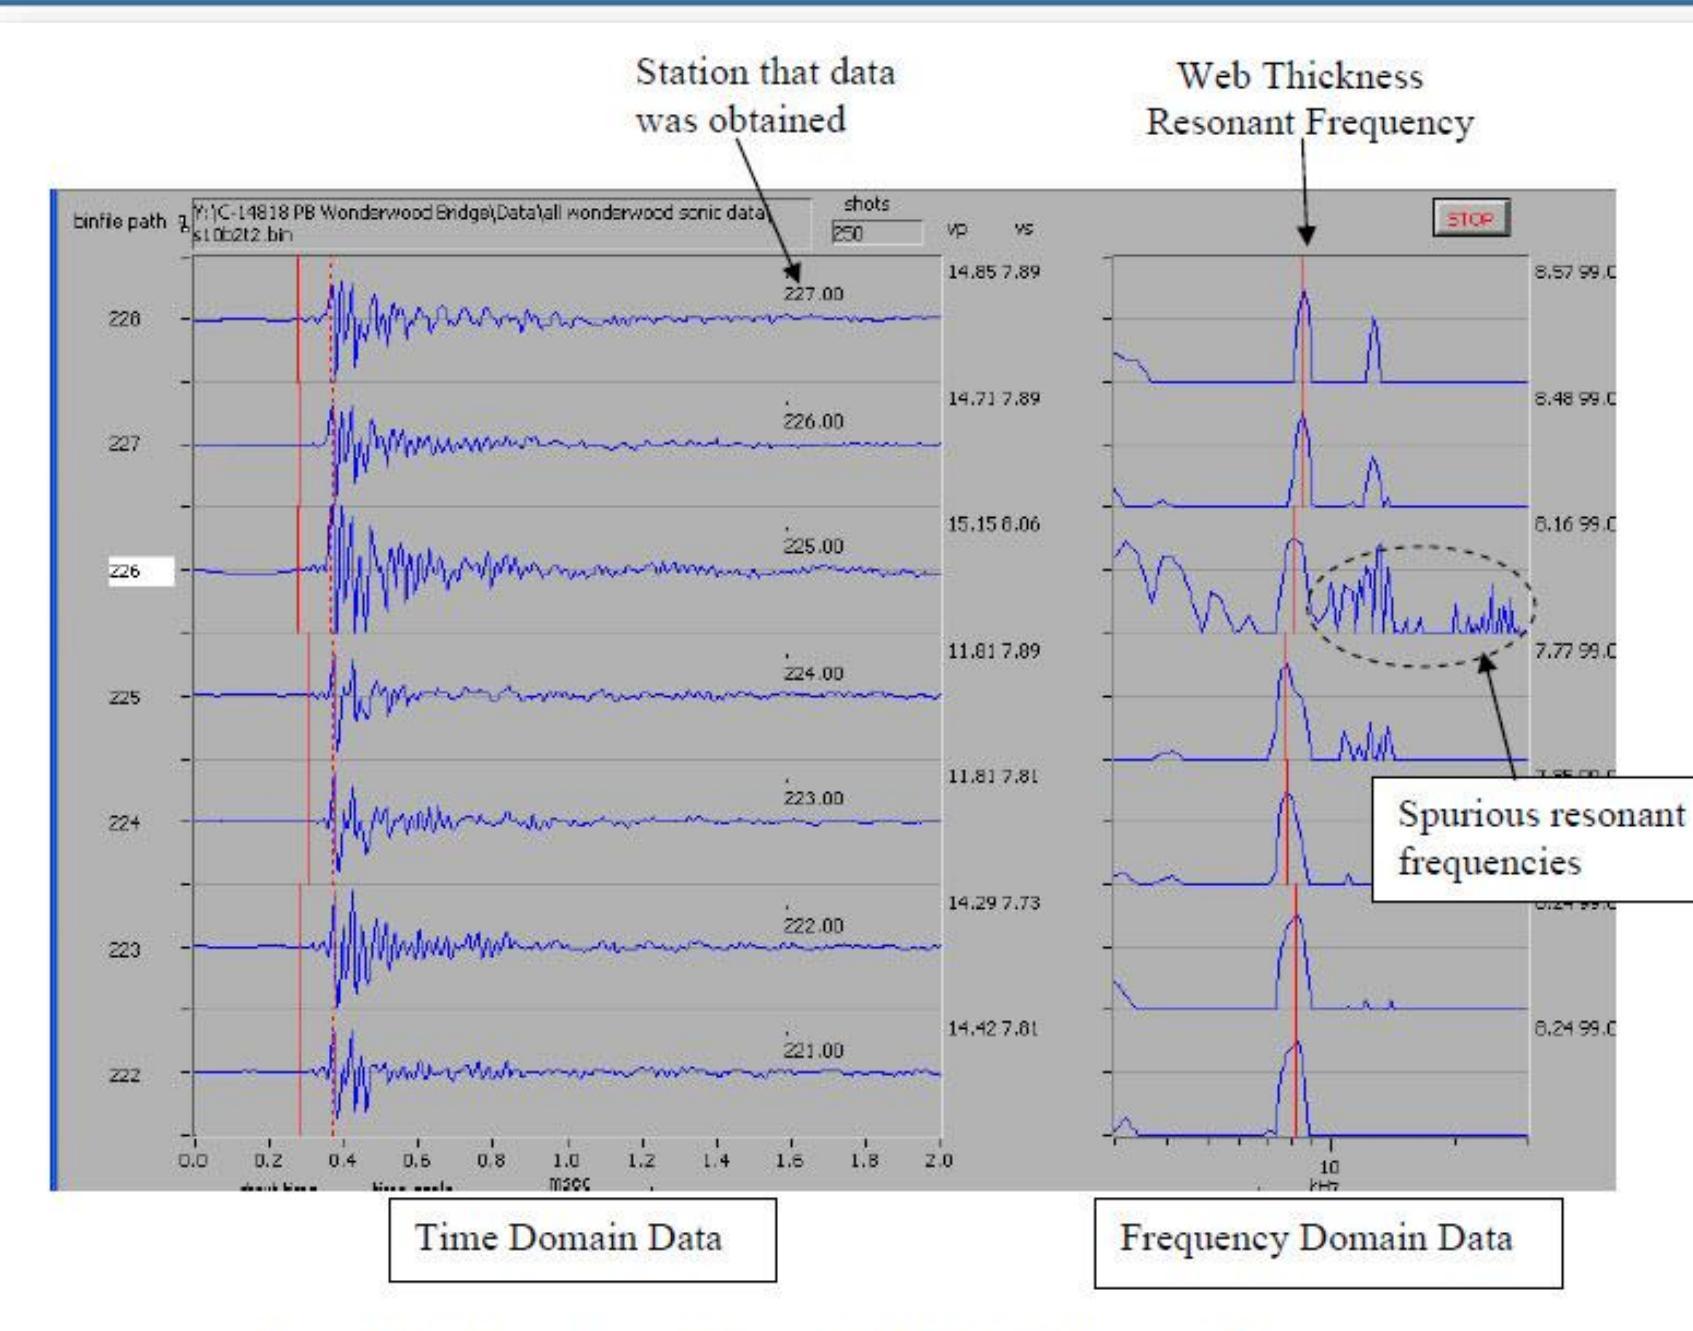
Figure 5: Samples of Time Domain and Frequency Domain data

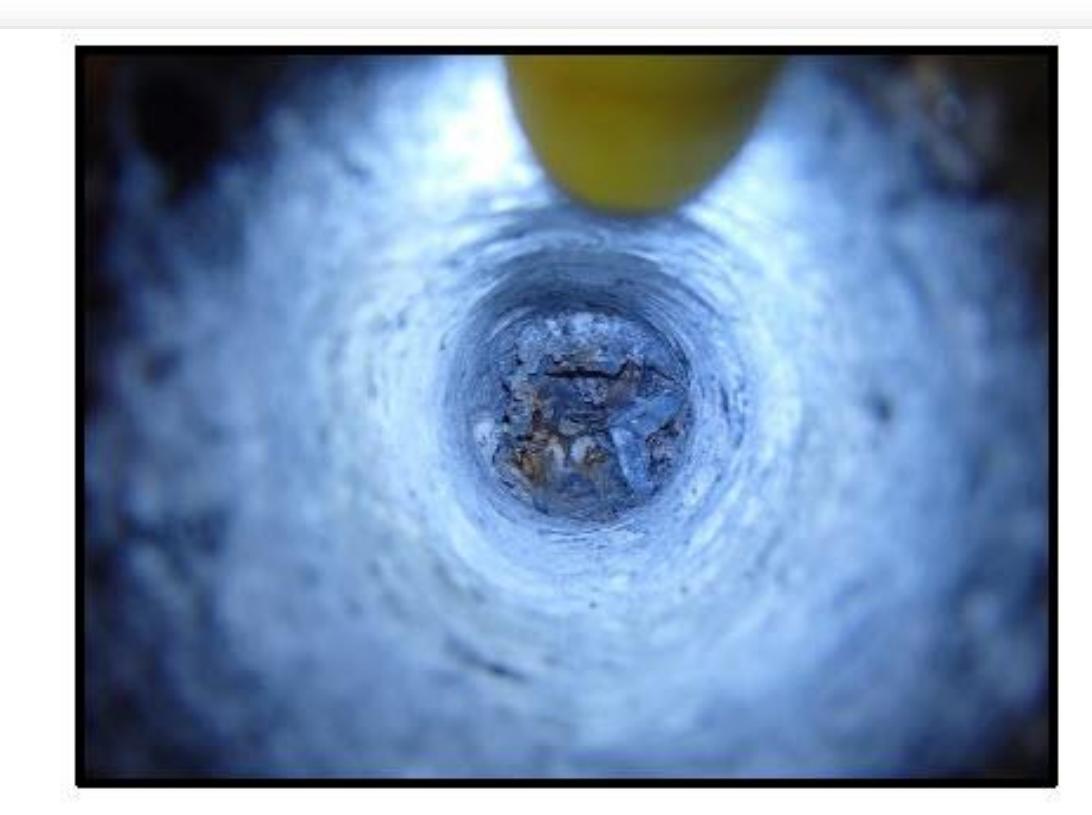
Figure 15B. Photograph inside the drilled hole at NDT Station No. 193 (S11-G4-T2).

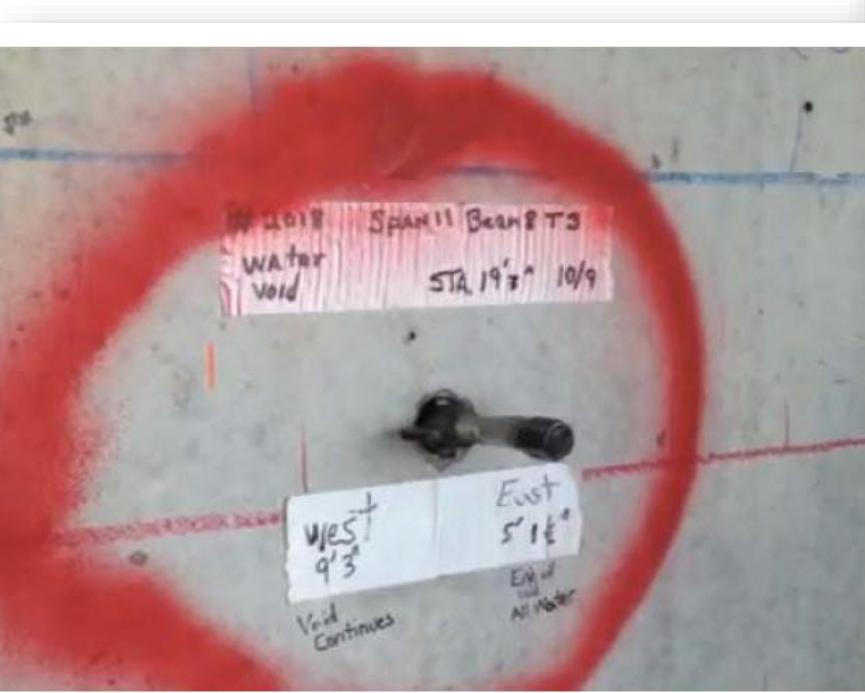
PHOTOGRAPH 6: Temporary protection plug

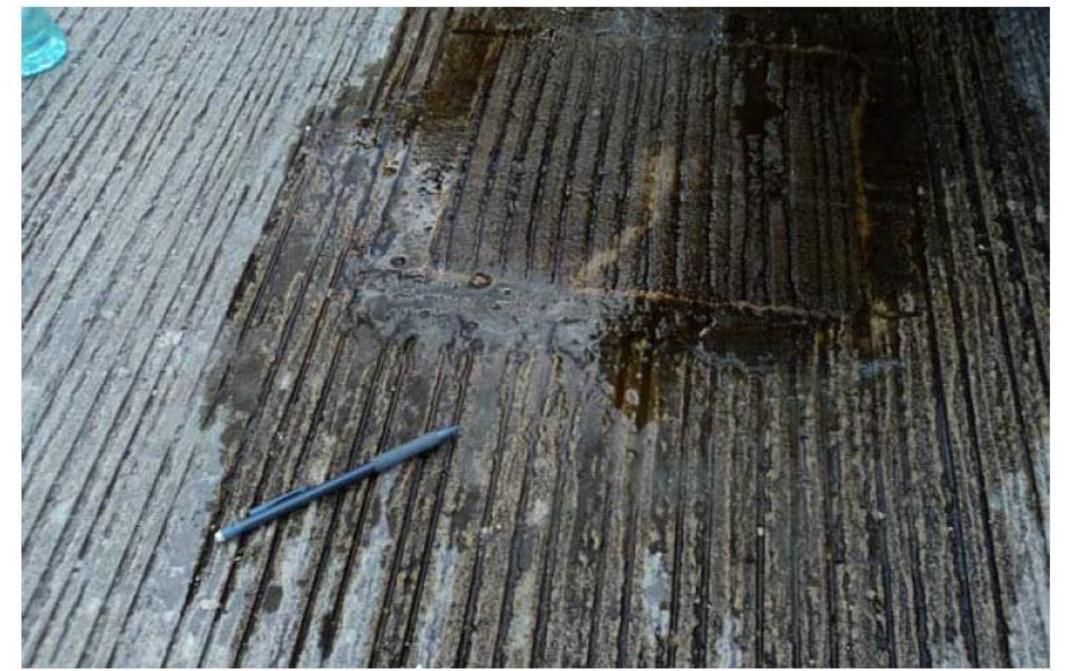
PHOTOGRAPH 7: Soapy water bubbles around patch in the deck

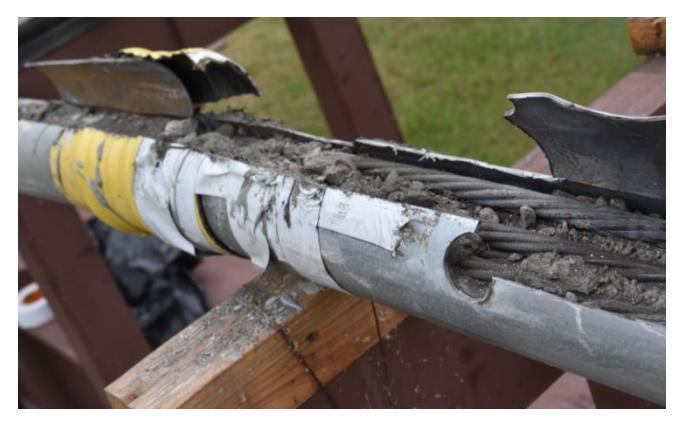
Rotation Nozzle Hydro-blasting

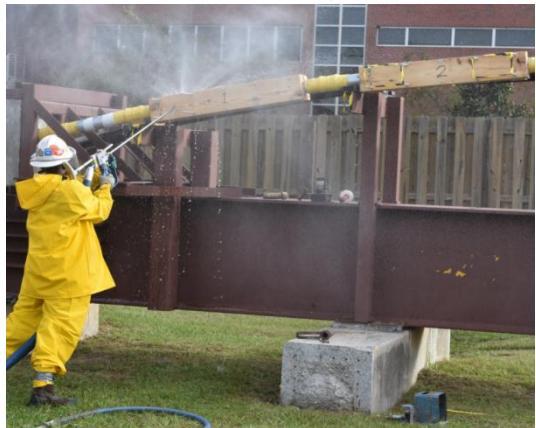
Hydro-blasting

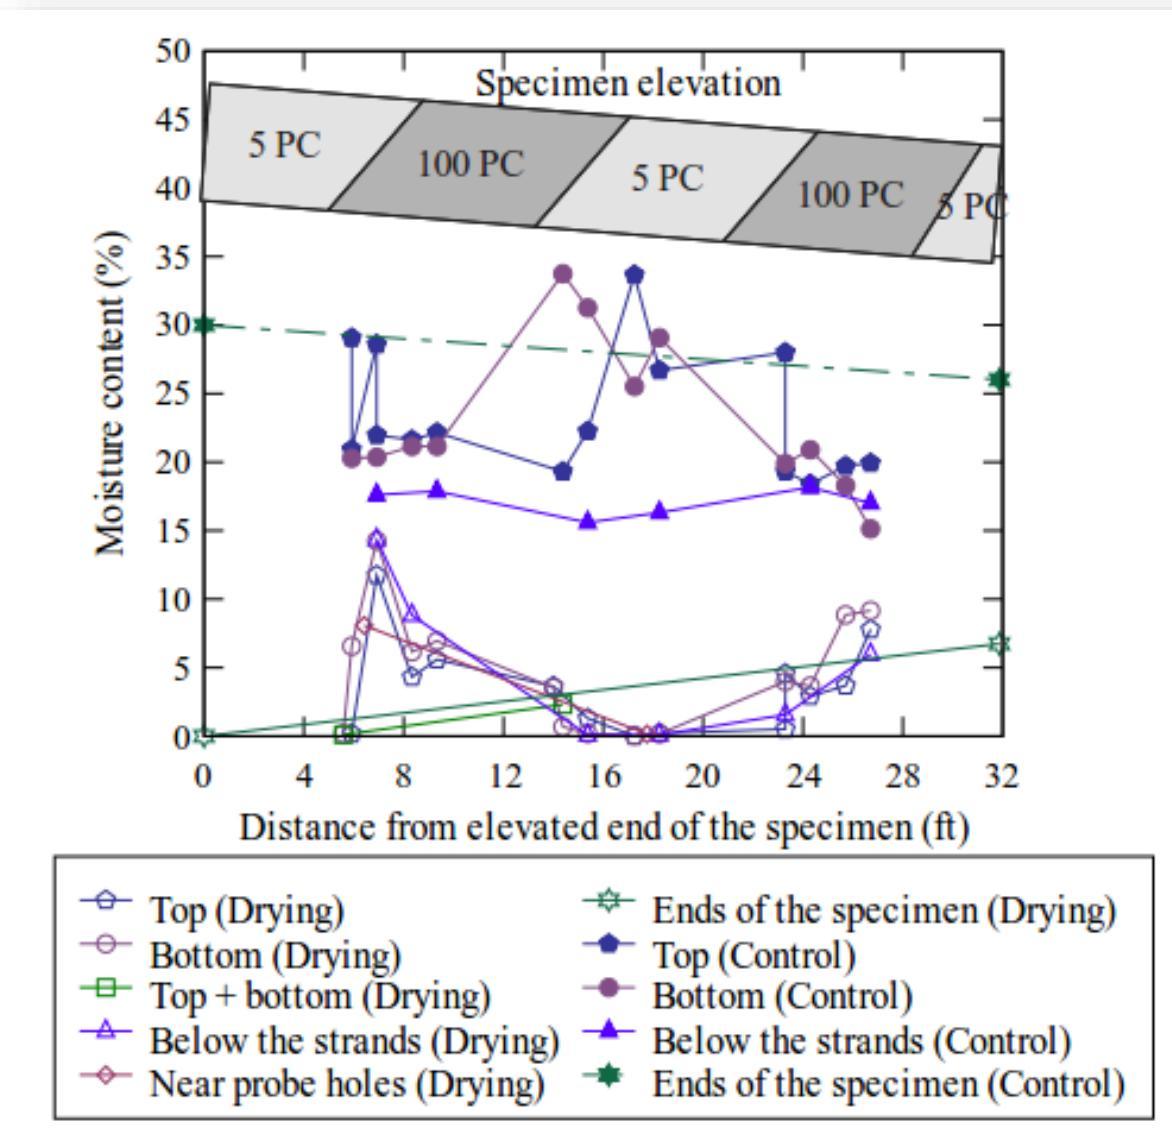
- Drying decreased moisture content
- Vacuum assisted drying shortened drying time
- A continuous power source is needed
- Humidity probes are unreliable after exposure to water

Figure 6 Comparison of moisture content for drying and control specimens 2

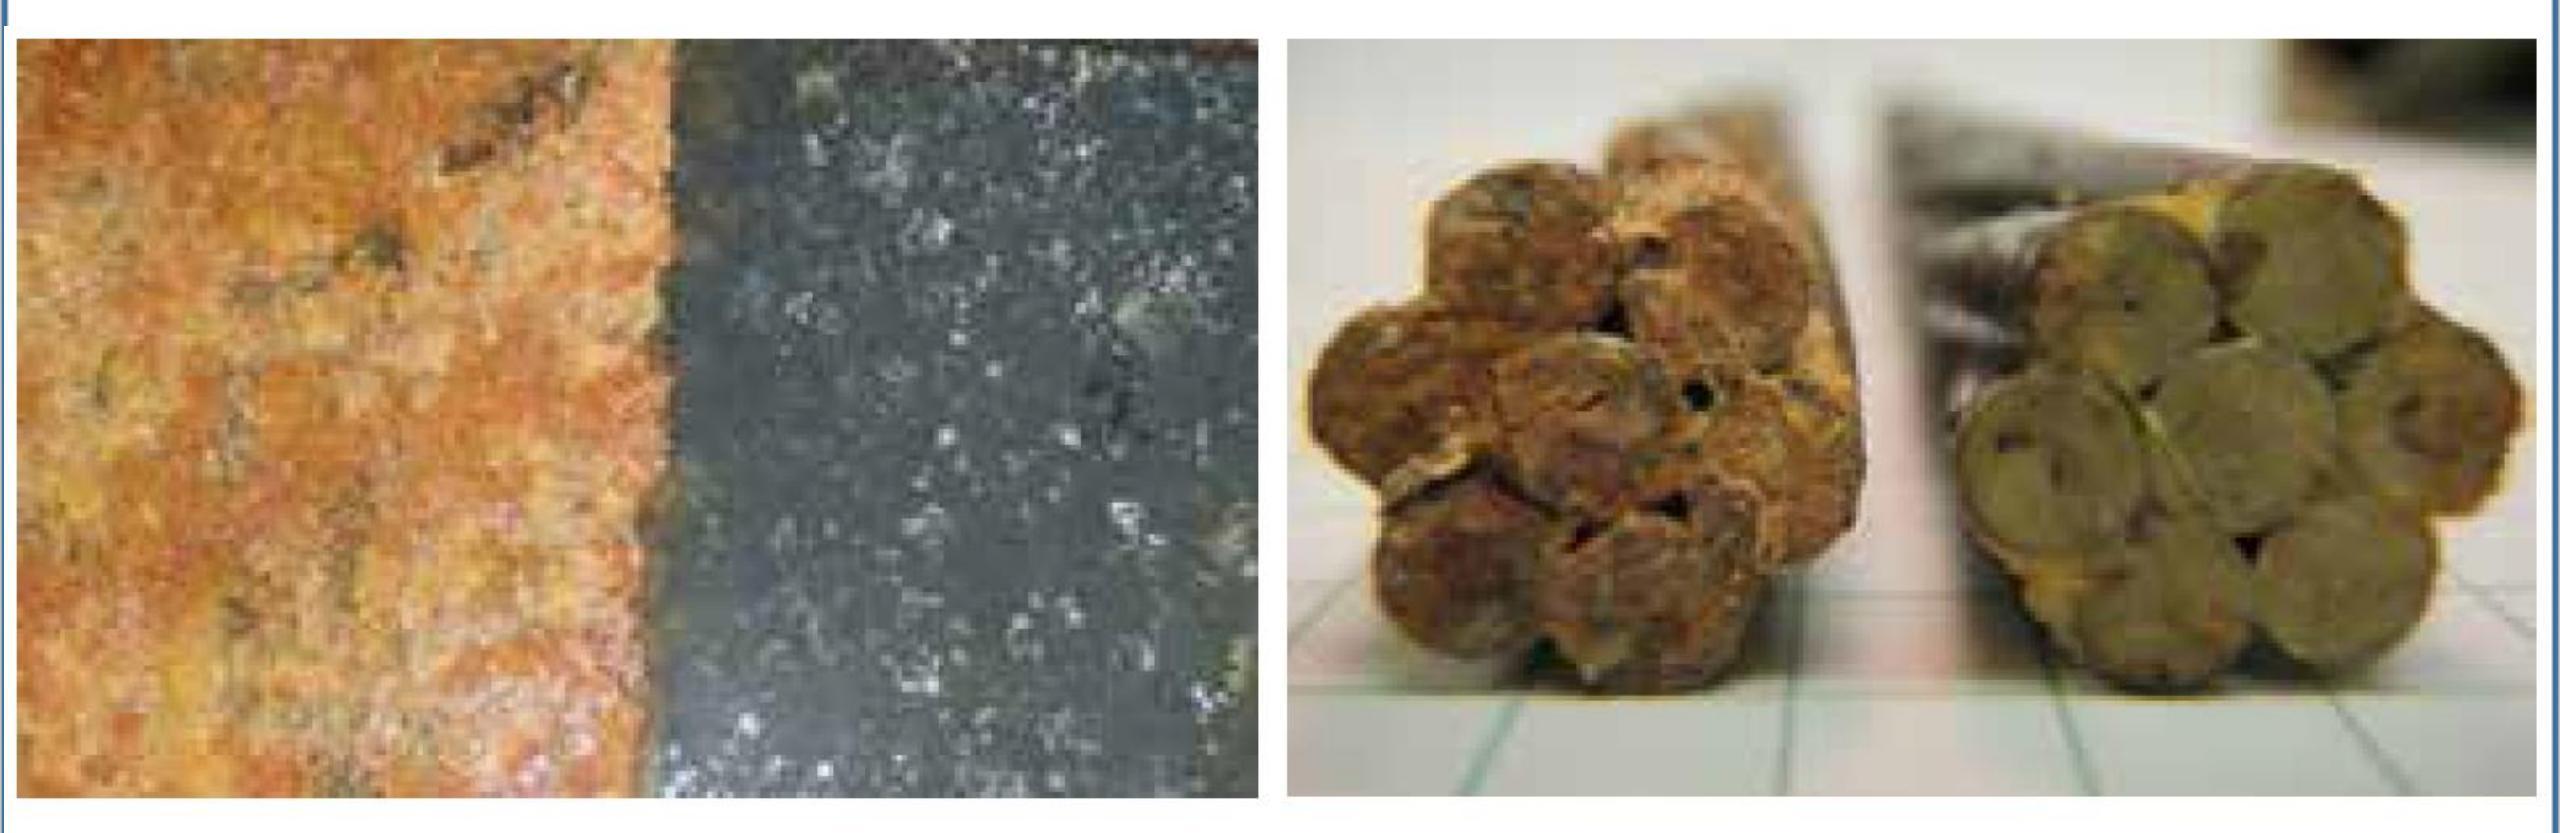
Salt spray testing on steel plate with untreated (left) and Post-Tech PTI treated section (right)

Salt spray testing on untreated (left) and Post-Tech PTI treated strand (right)

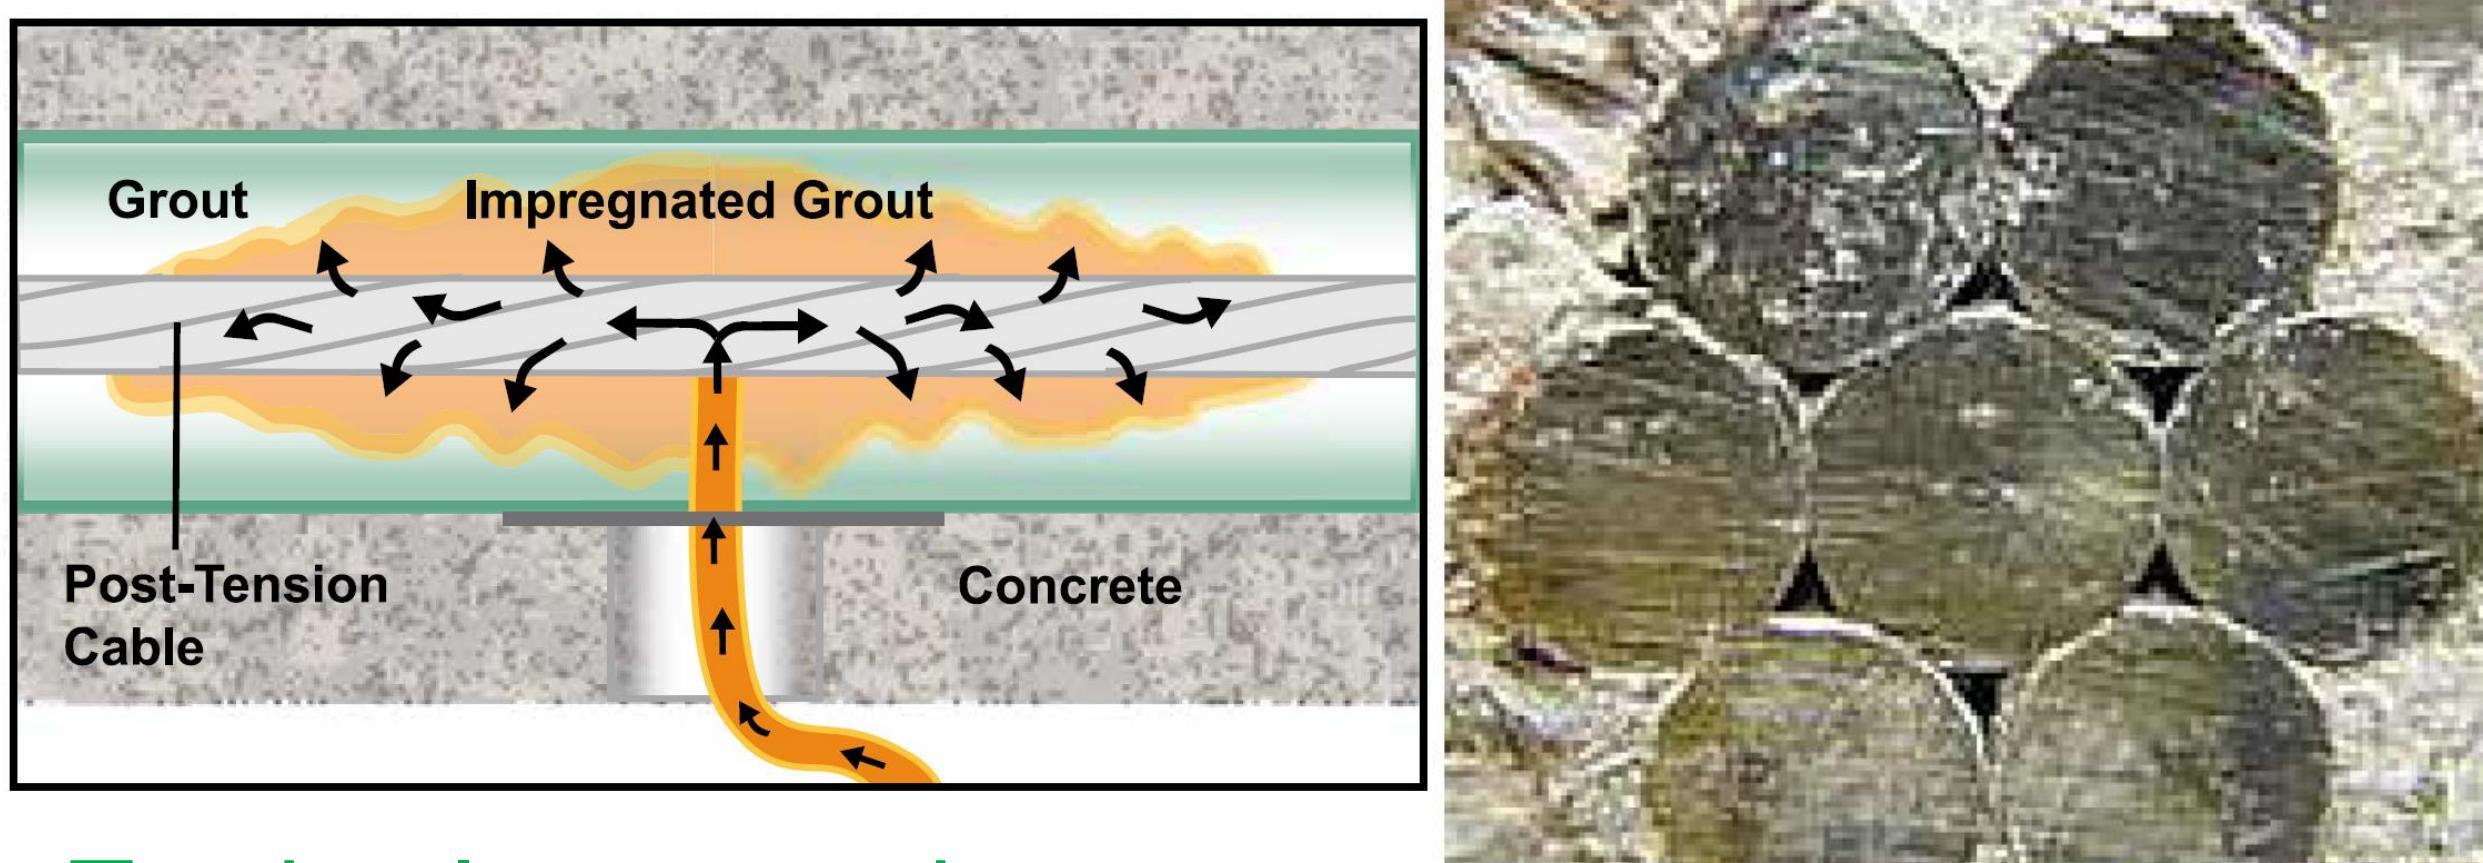
Tendon Impregnation

Post-Tech PTI flows along interstitial spaces in strands

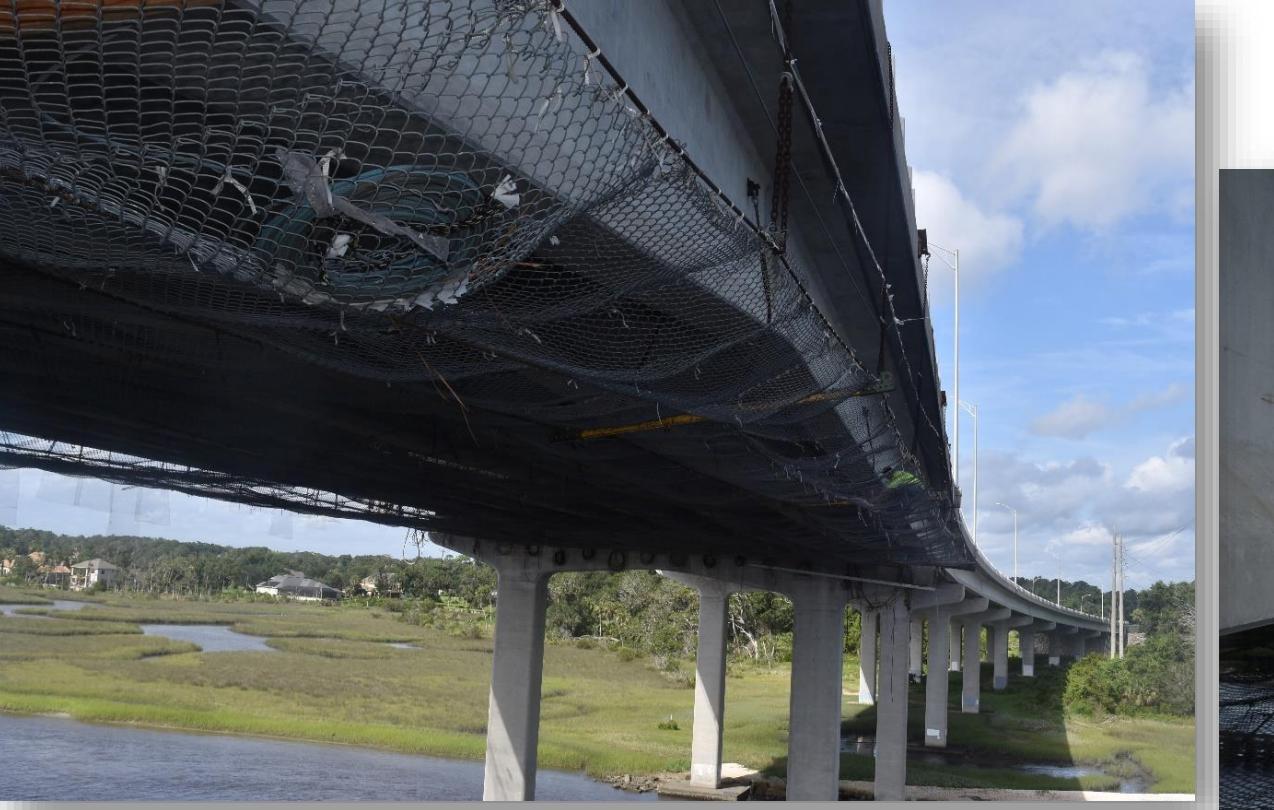
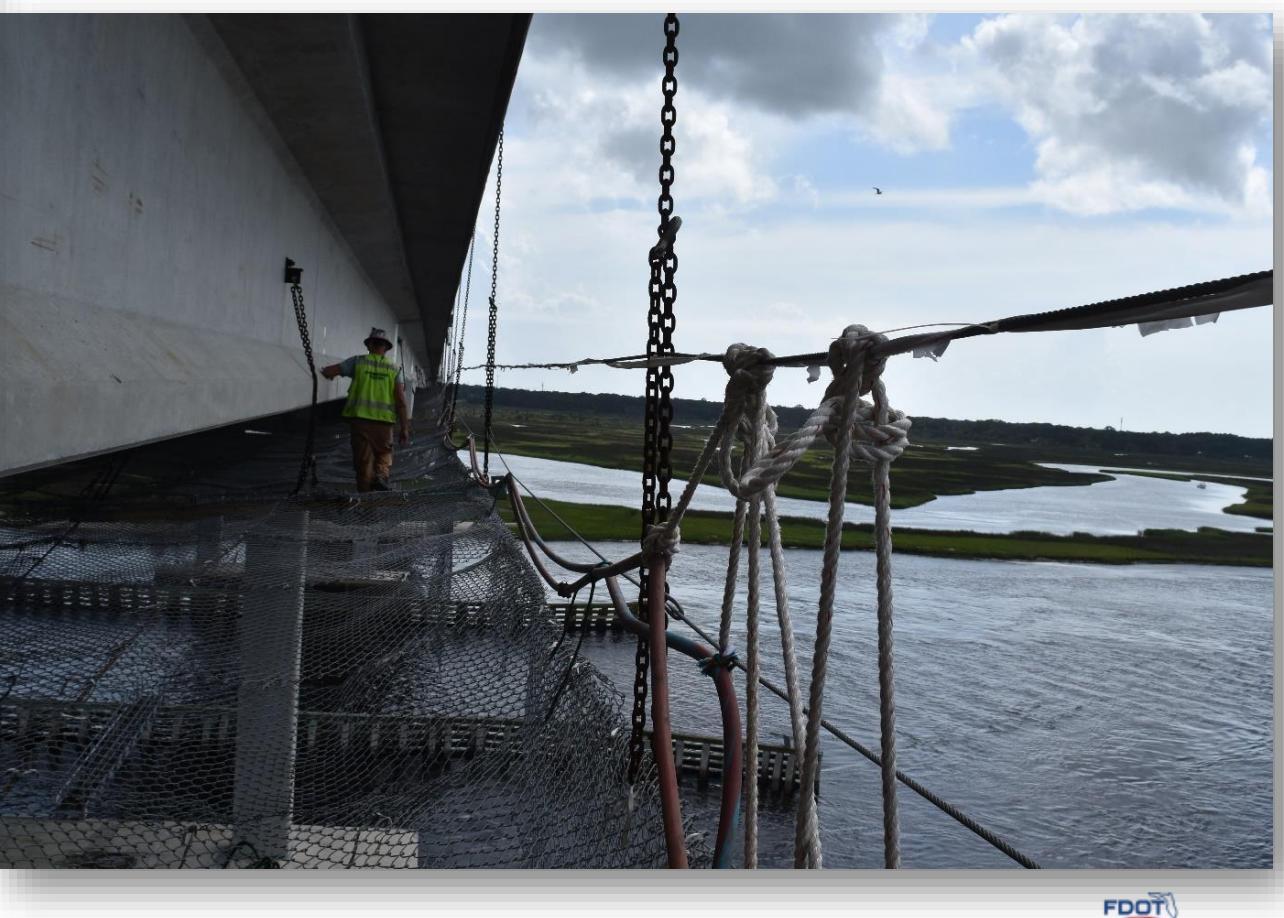
Phase 1 Repair Construction Work platform under the bridge set up

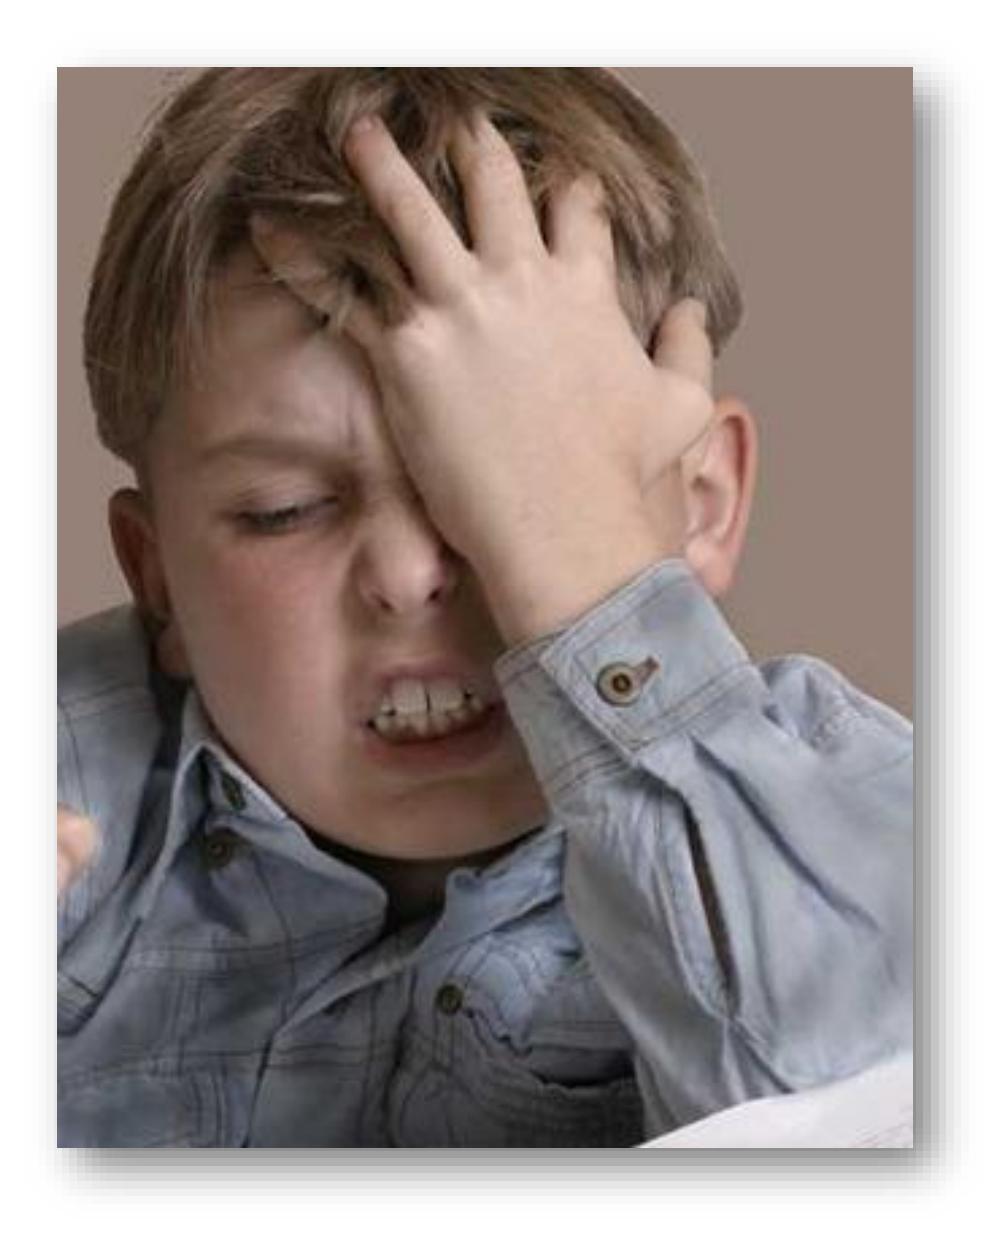
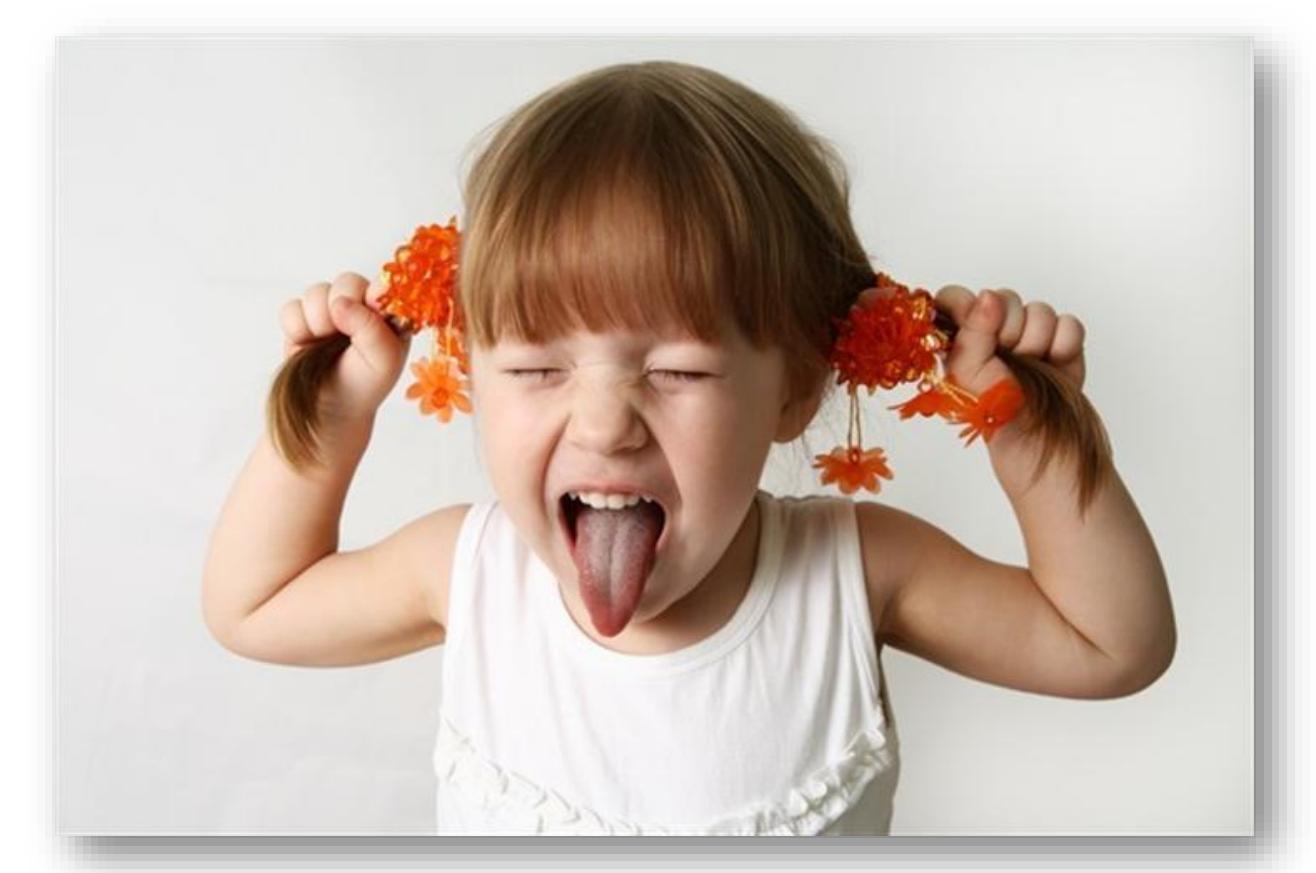
Alright why is this not working.....

Weather Stripping (WS) + Clamp
Epoxy + Clamp
Epoxy + Clamp + Epoxy

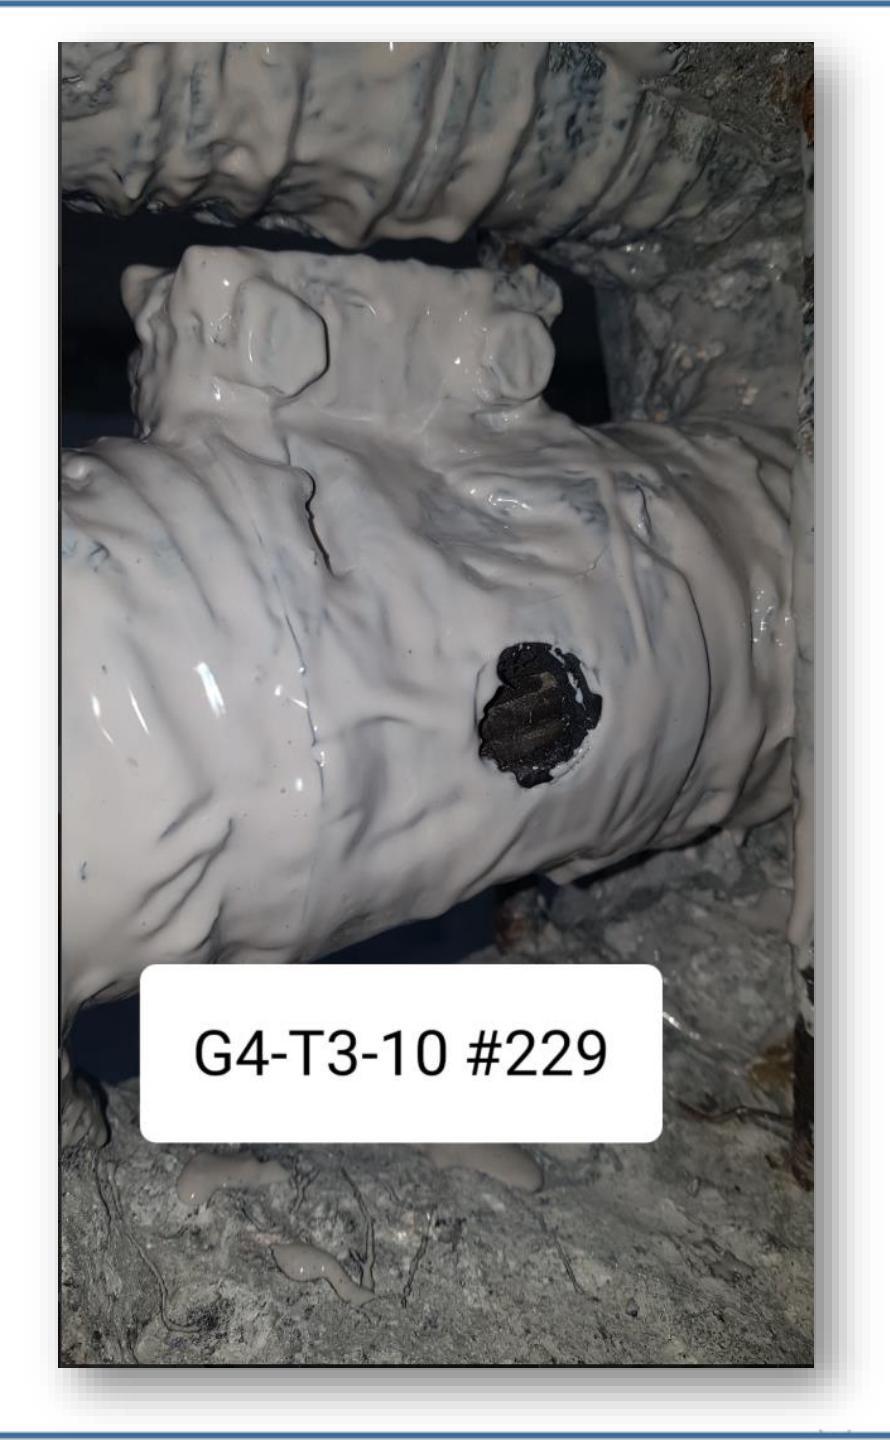
6. Epoxy + WS + Clamp +Epoxy + Cure time + Bonding Agent + Concrete ☺

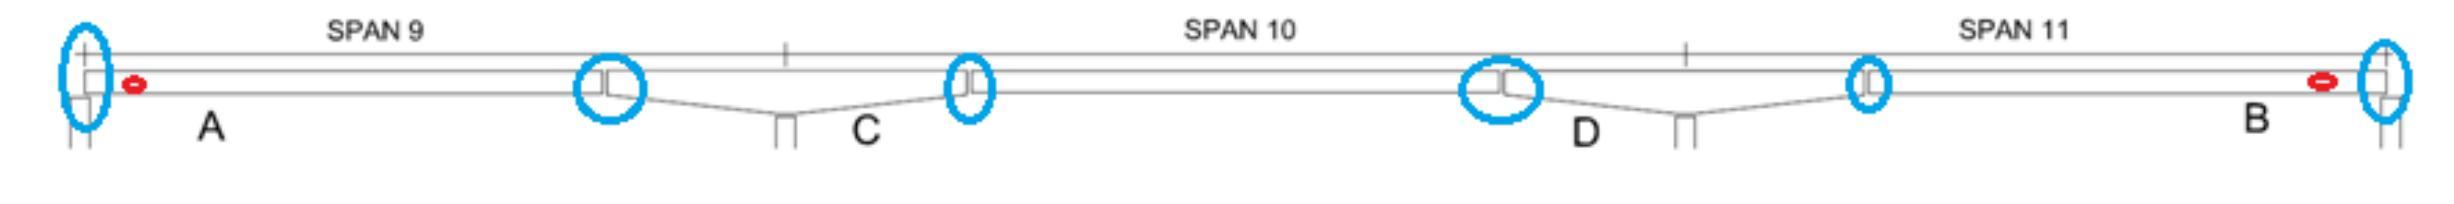
ELEVATION - SPANS 9, 10 & 11

Major Leak Zones
