Wonderwood Connector Bridge Post-Tensioning Tendons Investigations and Phase 1 Repair

Teddy Theryo, Ivan Lasa, Marcelino Aguirre, Daniel Rosa

- **Bridge No. 720677**
- Wonderwood Connector Bridge is located over the Inter-coastal Waterway on SR 166, north east of Jacksonville, FL
- The total bridge length is 3584' and 90'-9" wide deck consisted of 8 lines of prestressed concrete I girders.
- The focus of this presentation is the three-span continuous Post-tensioned spliced girder main span bridge of 197'-250'-197' (total length of 644')

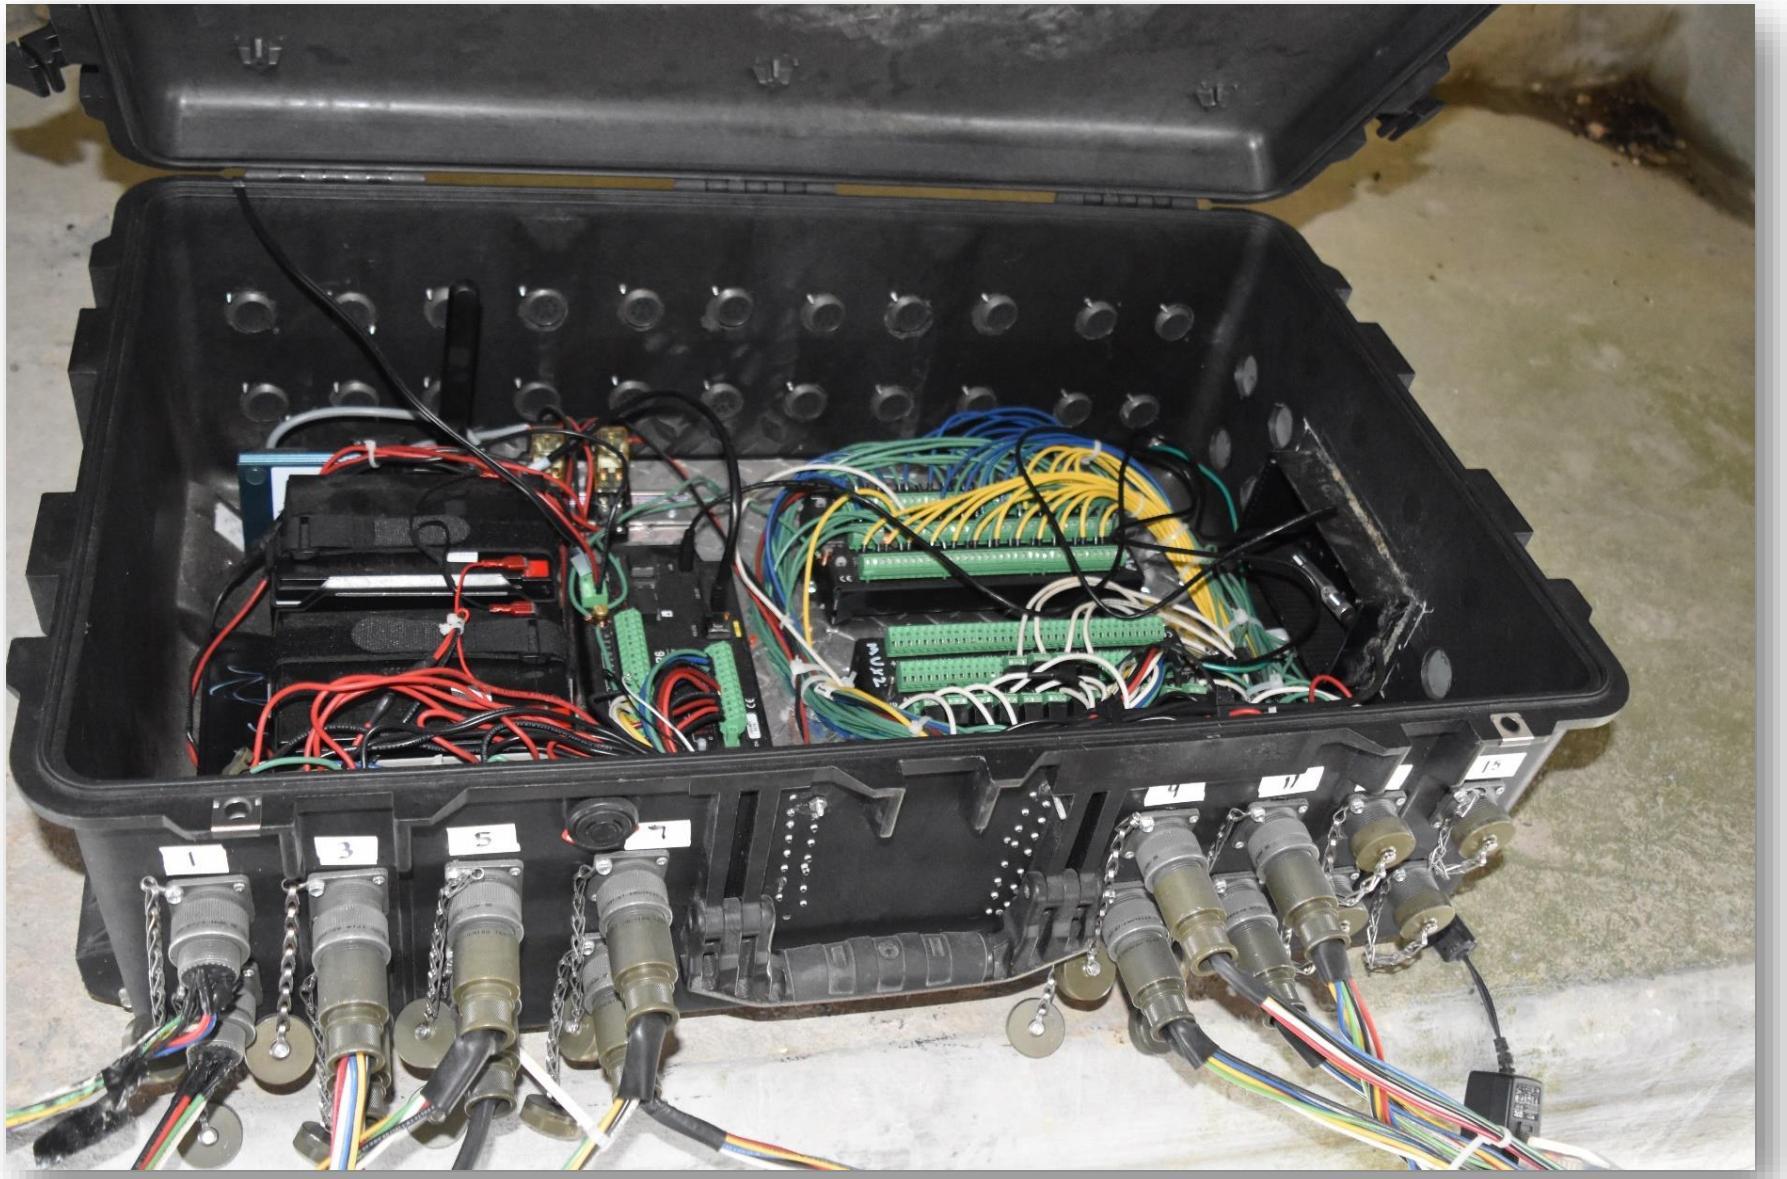
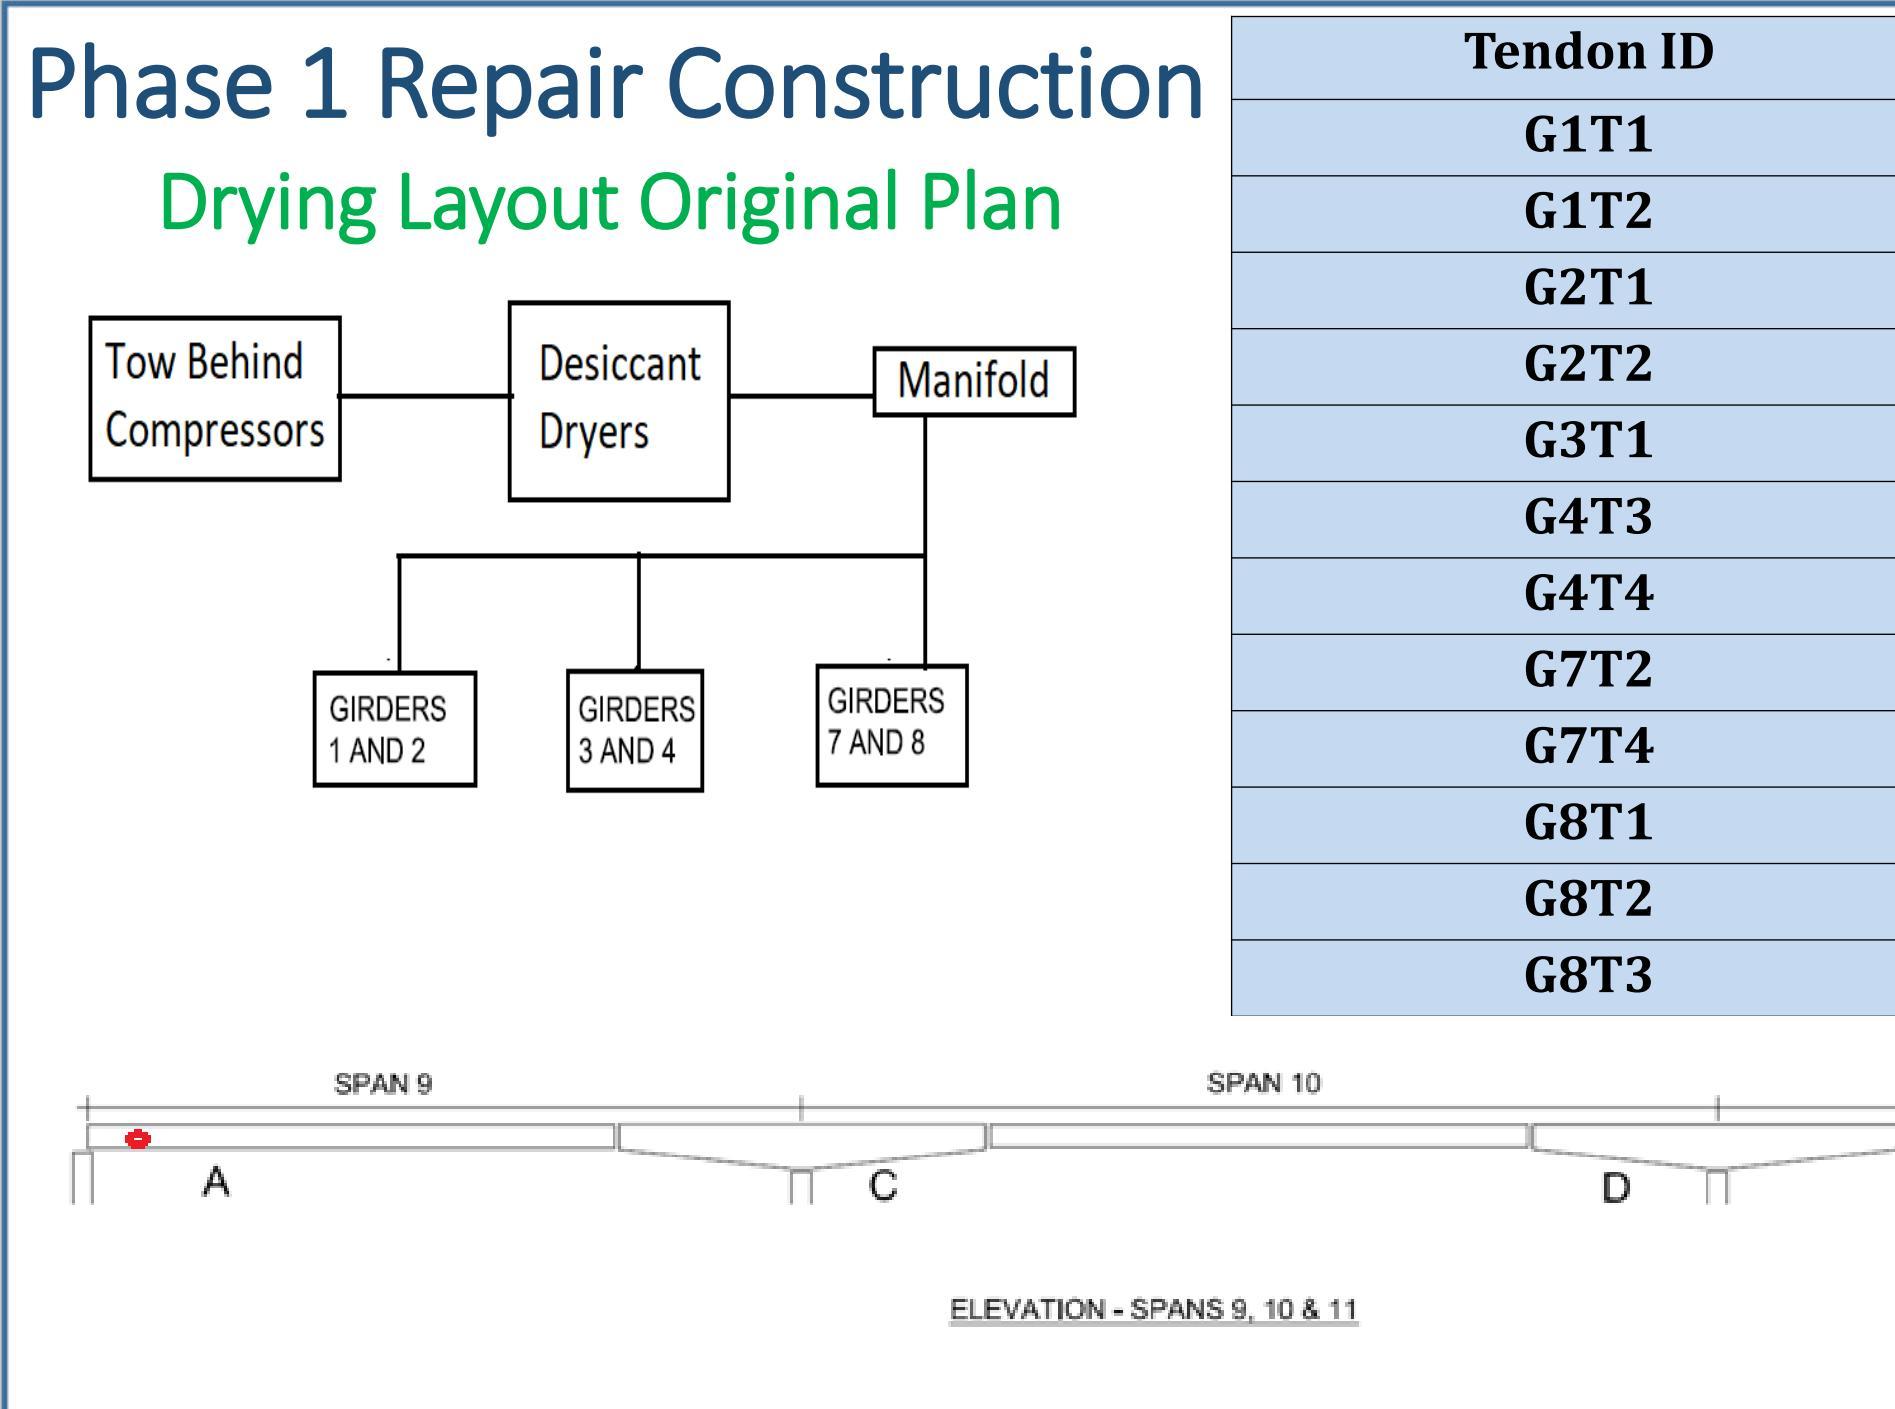
Phase 1 Repair Construction Air Sensors and Remote Monitoring Units (RMU'S)

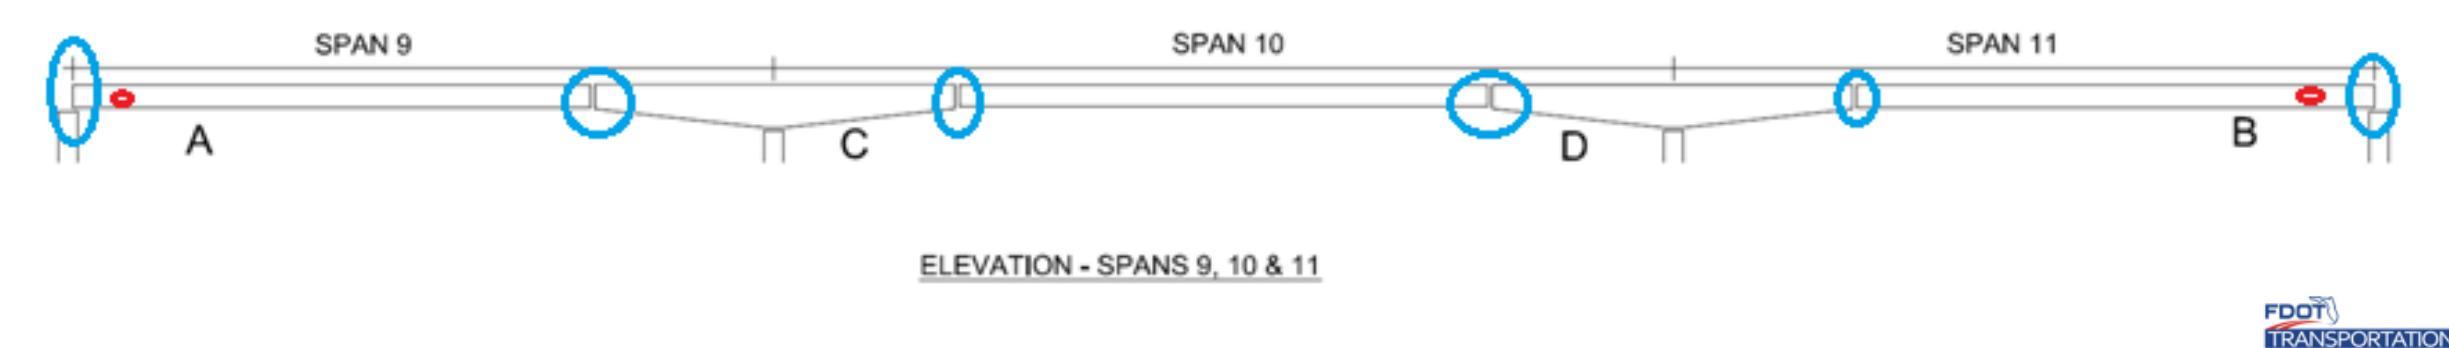
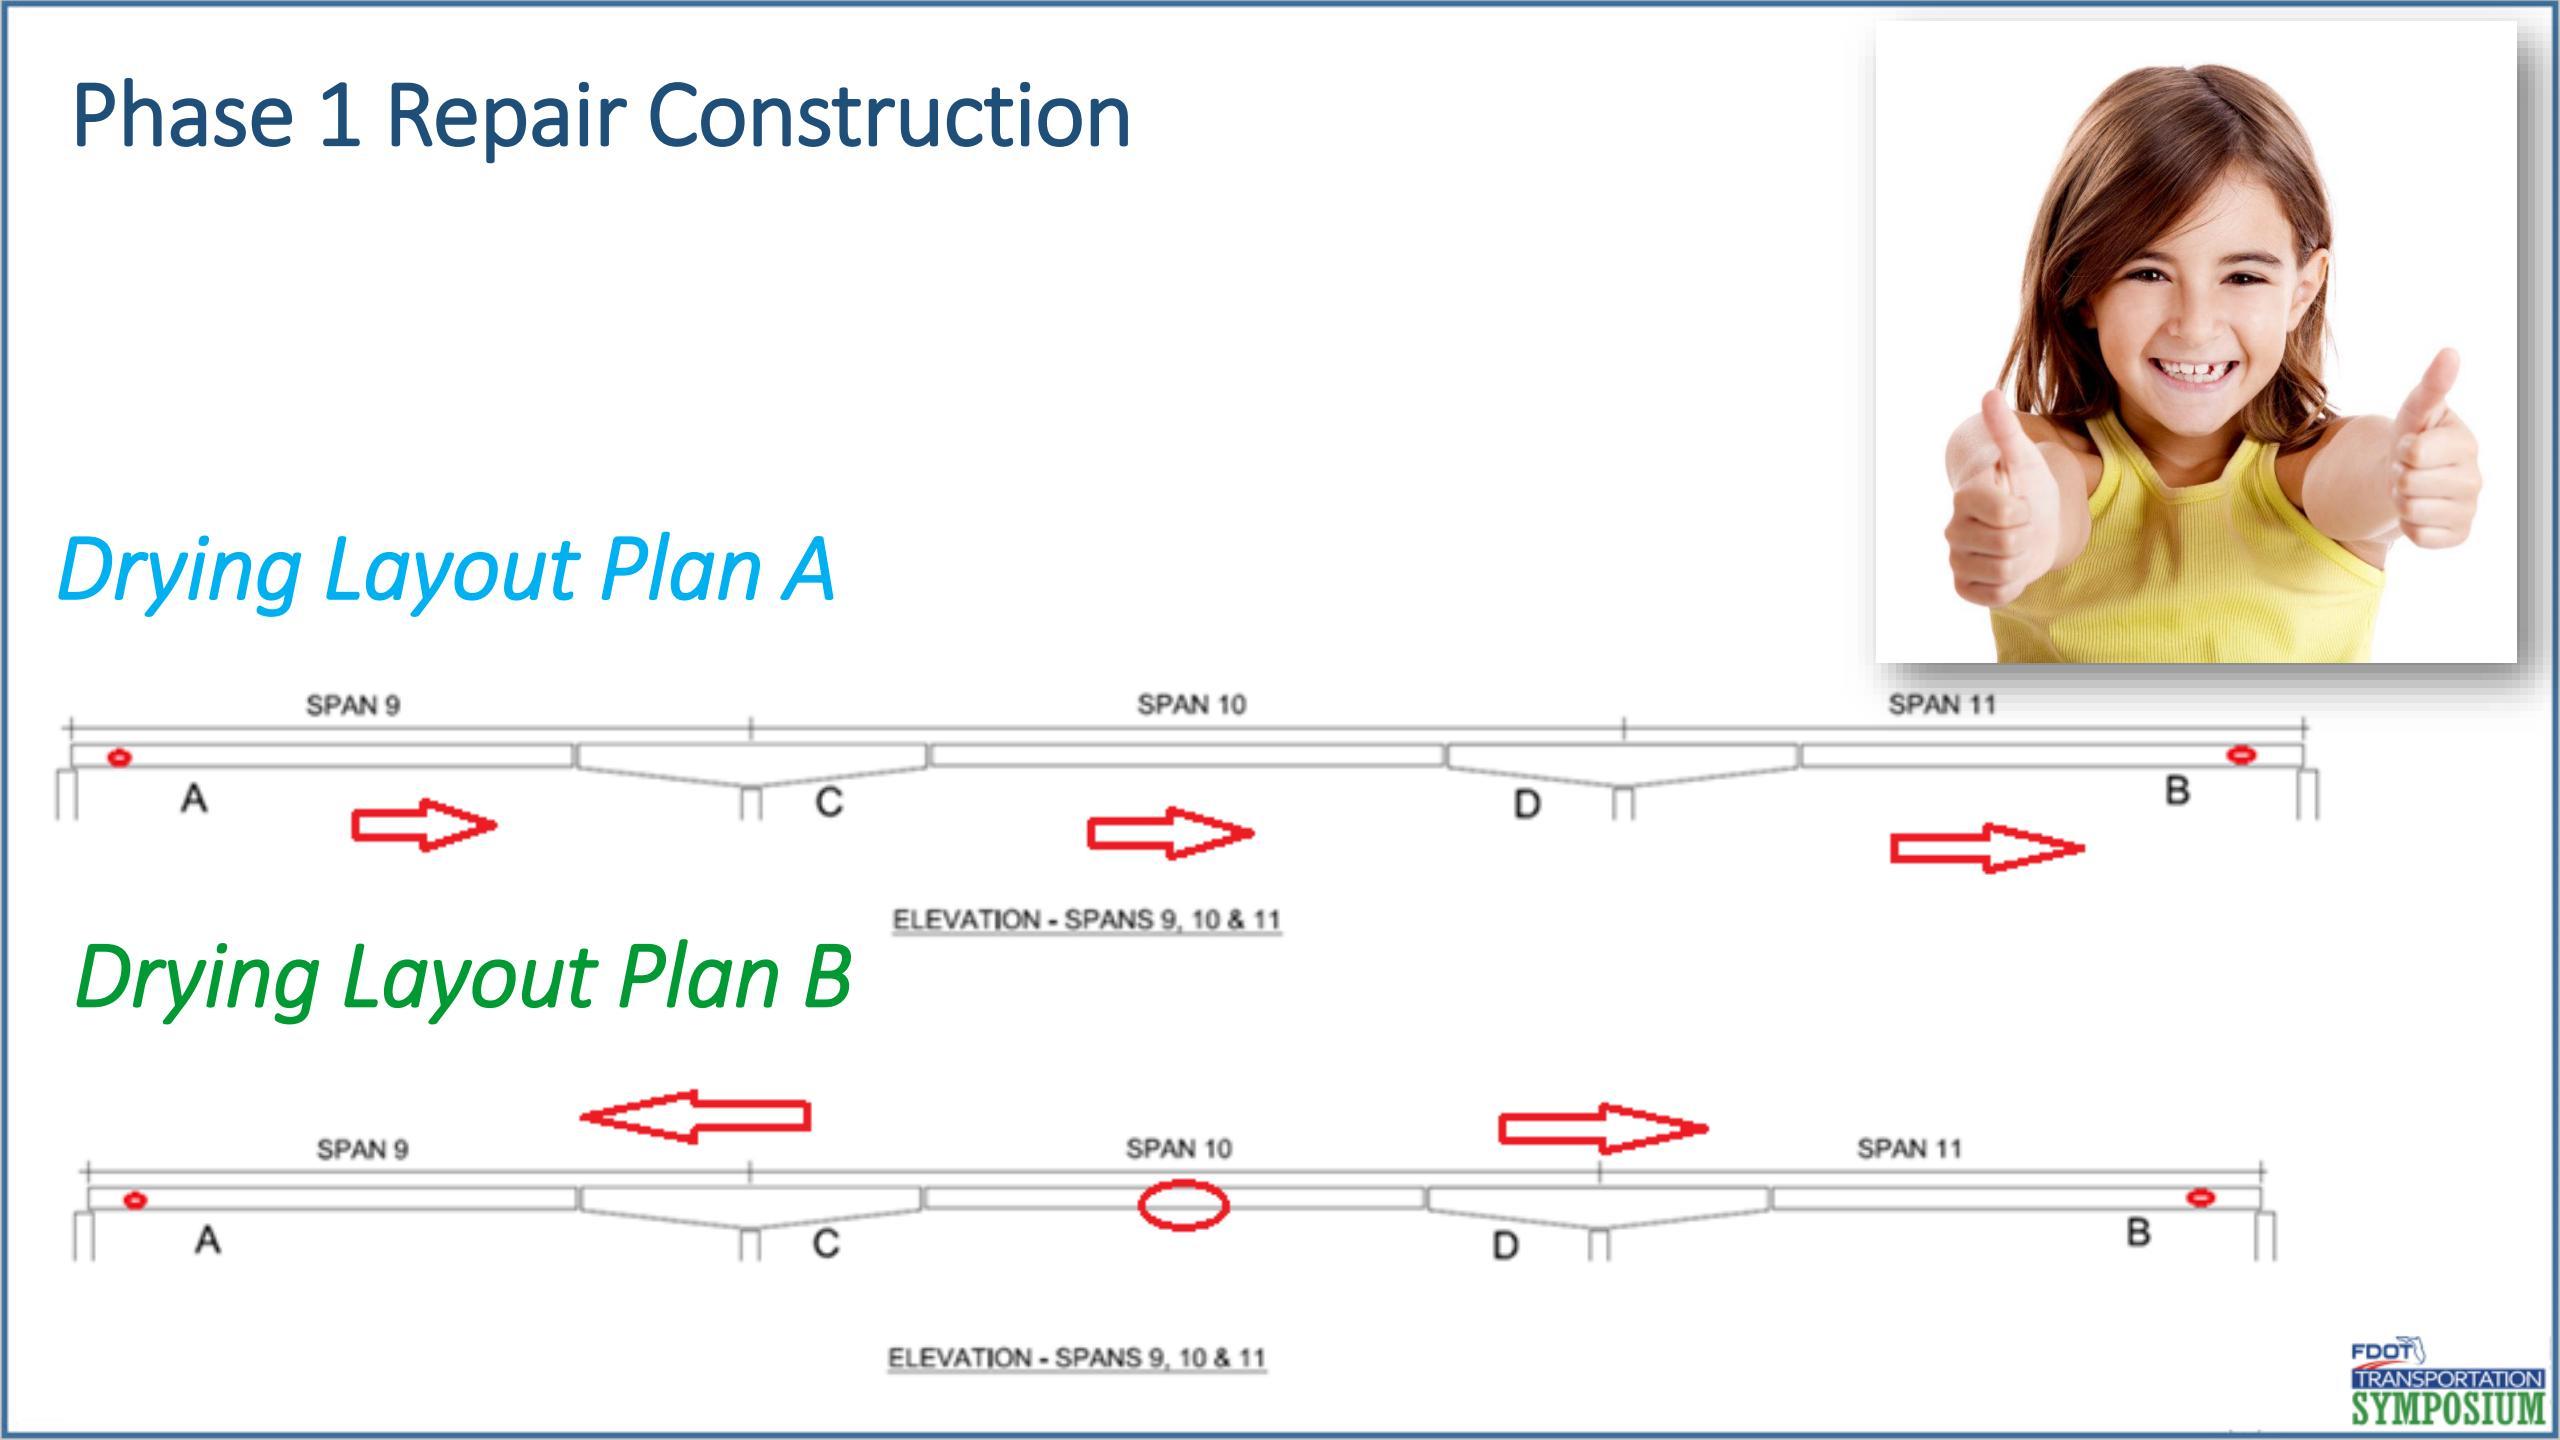
But Wait....What About Those Leaks?

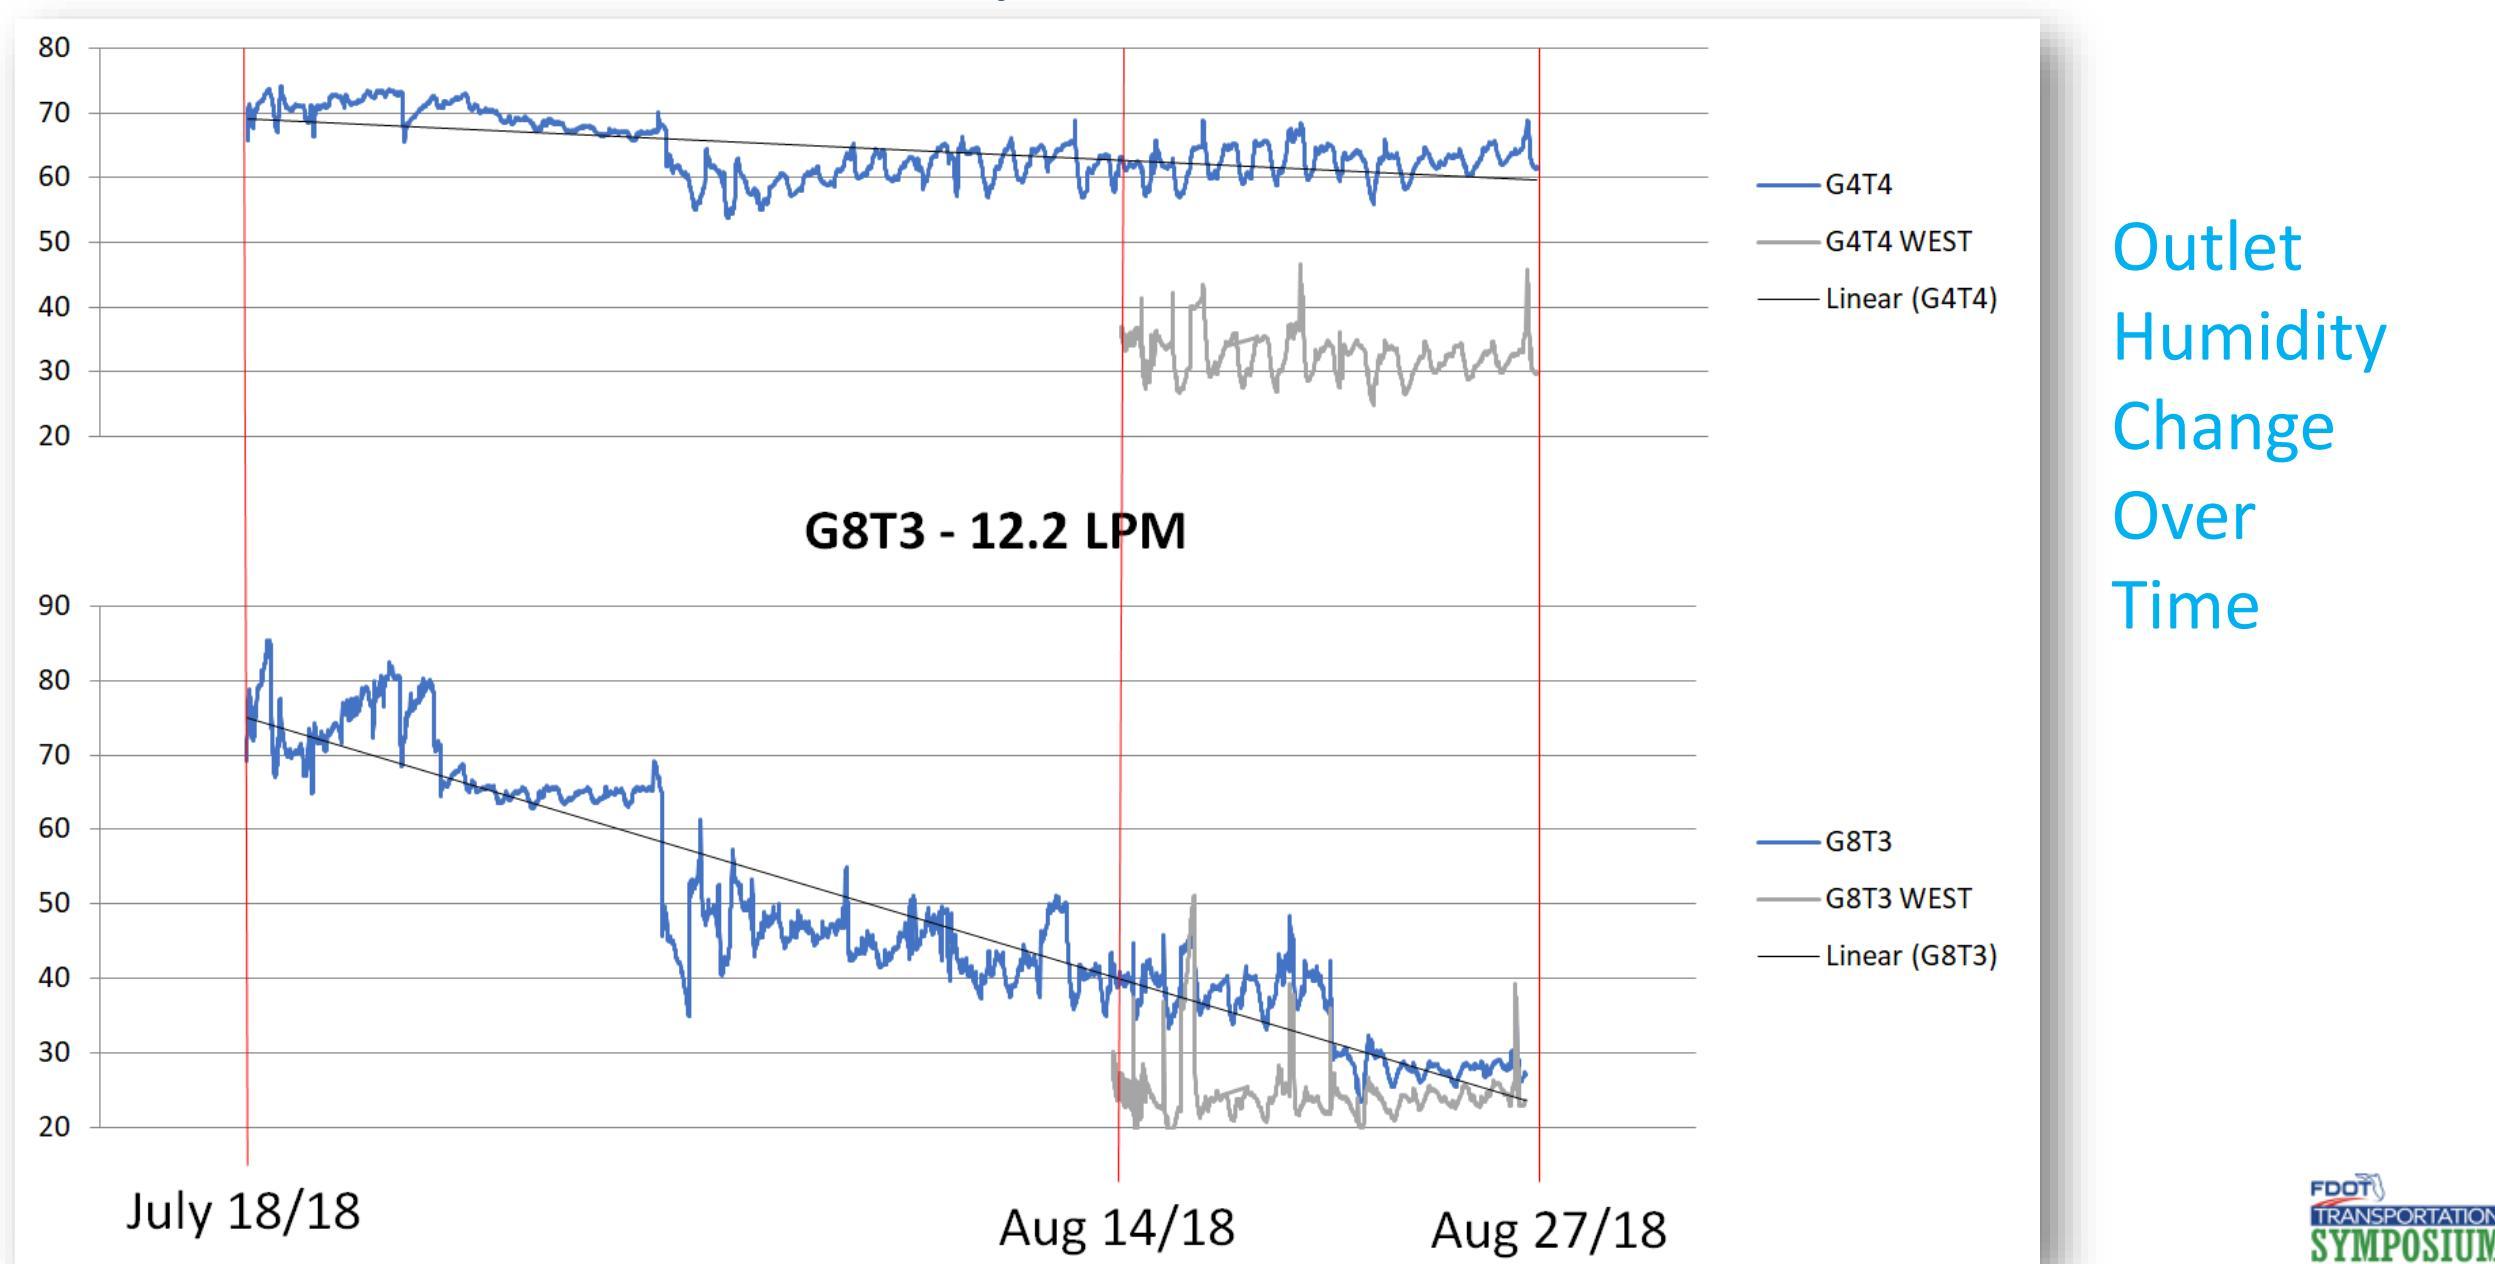
Flow rate comparison End-to-end vs Center-out

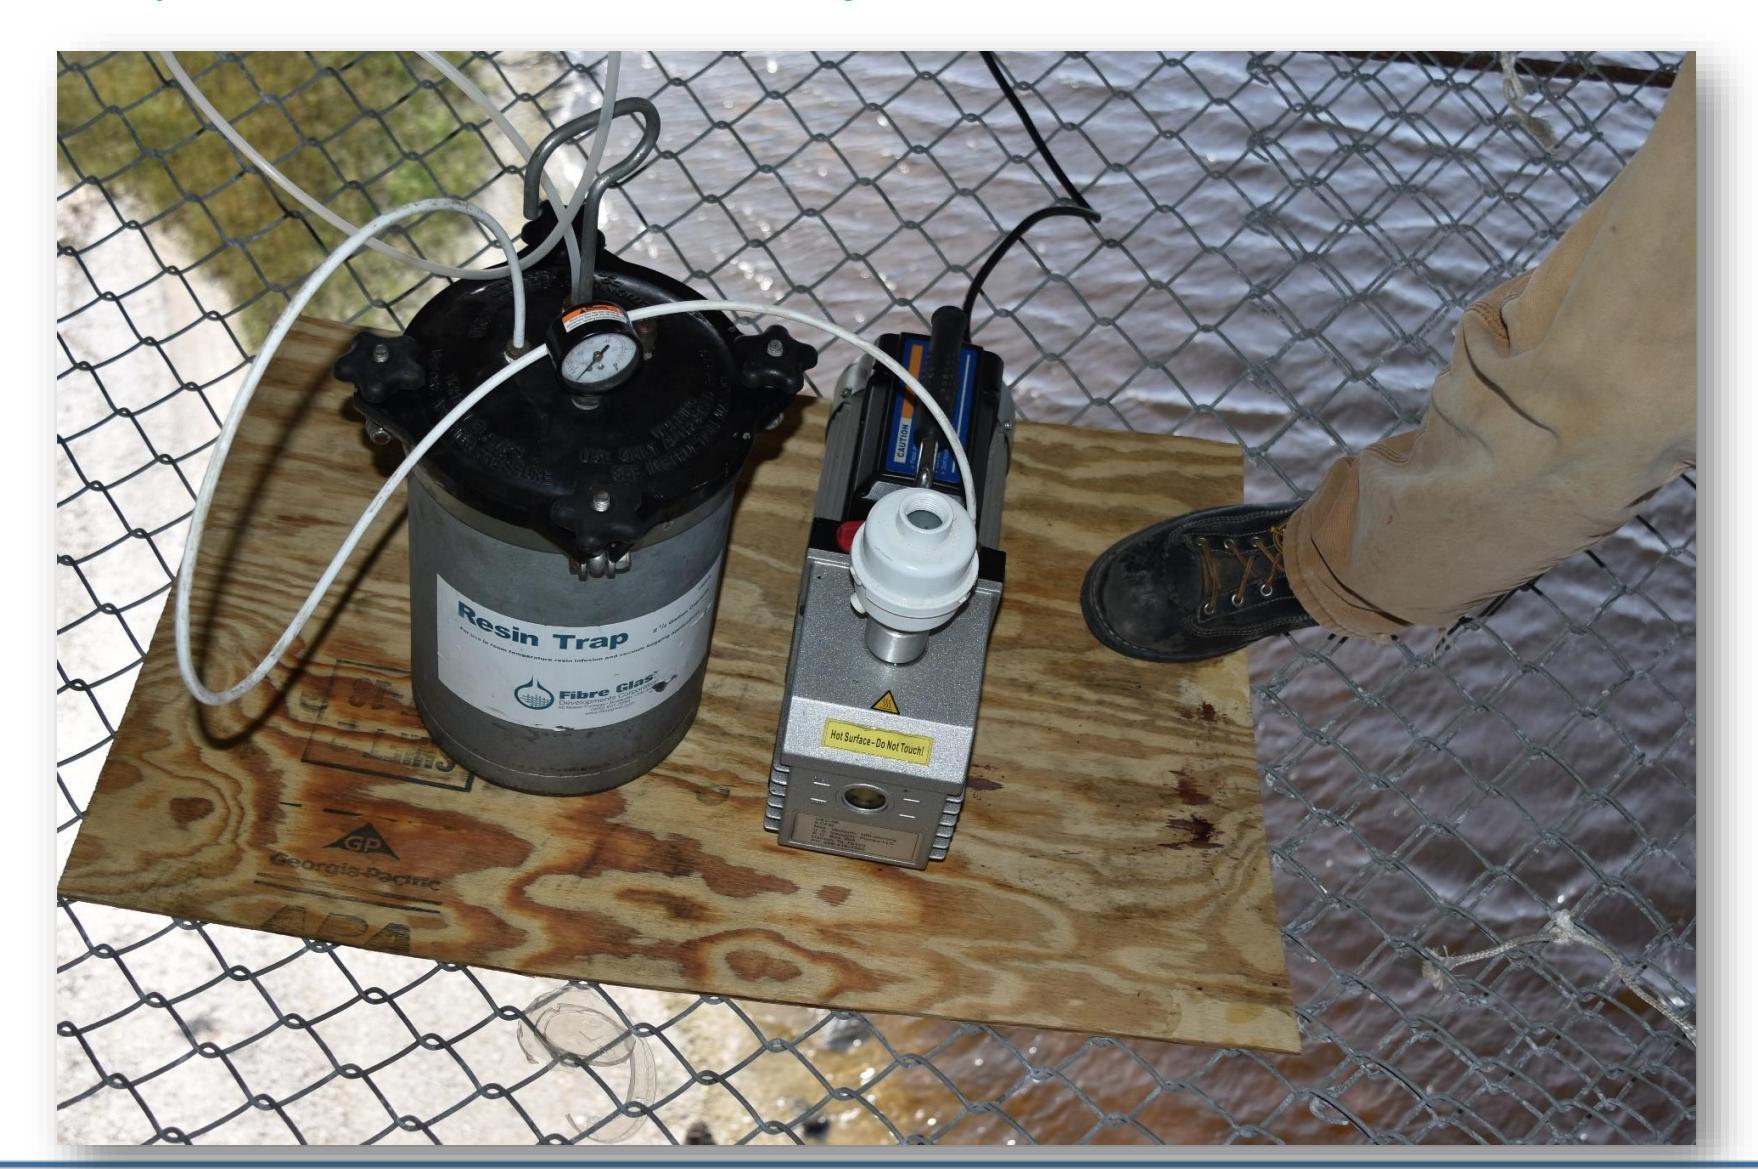
Phase 1 Repair Construction Vacuum Pump Assistance for Injection

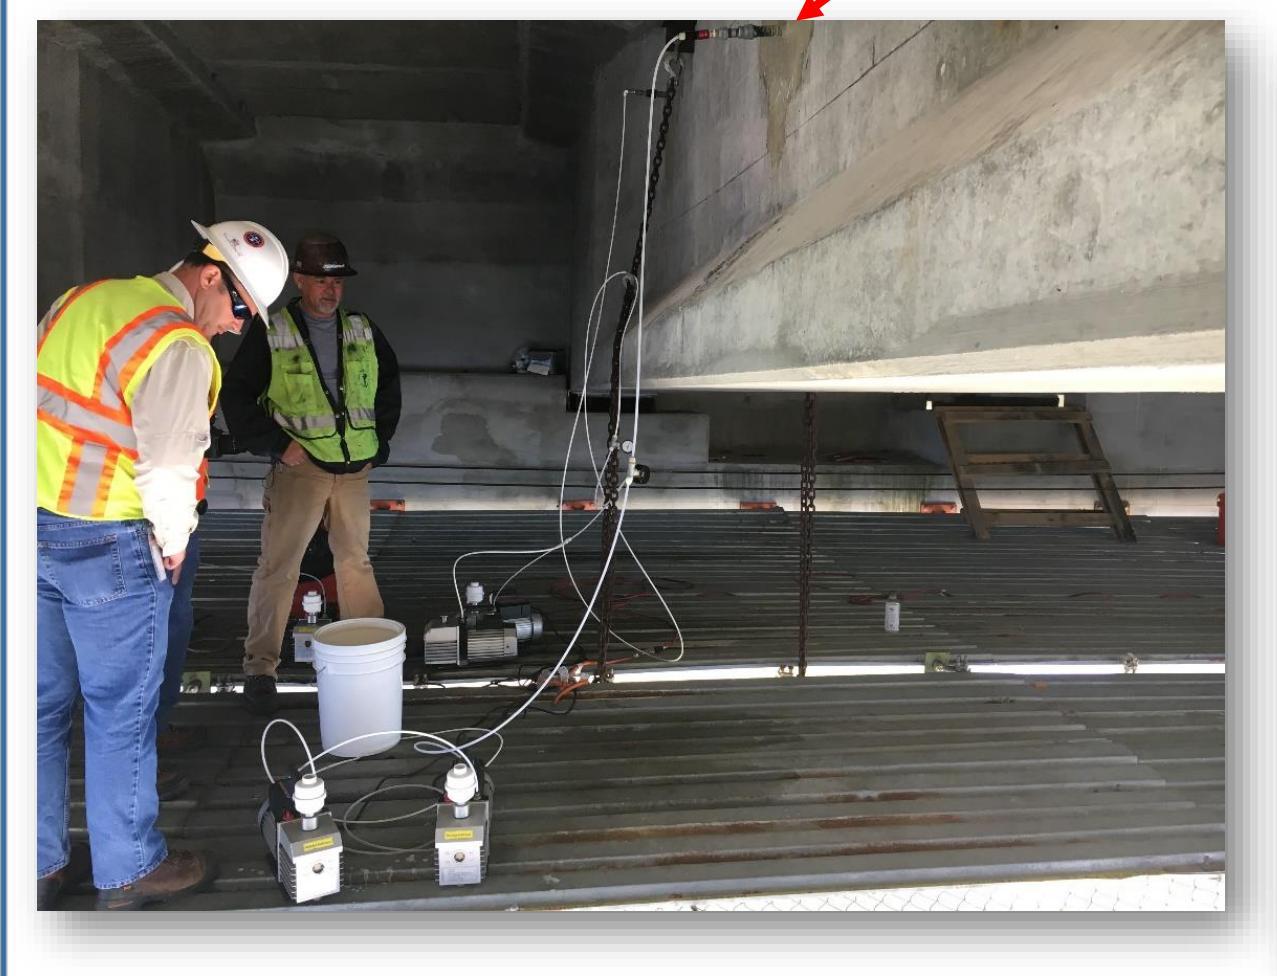
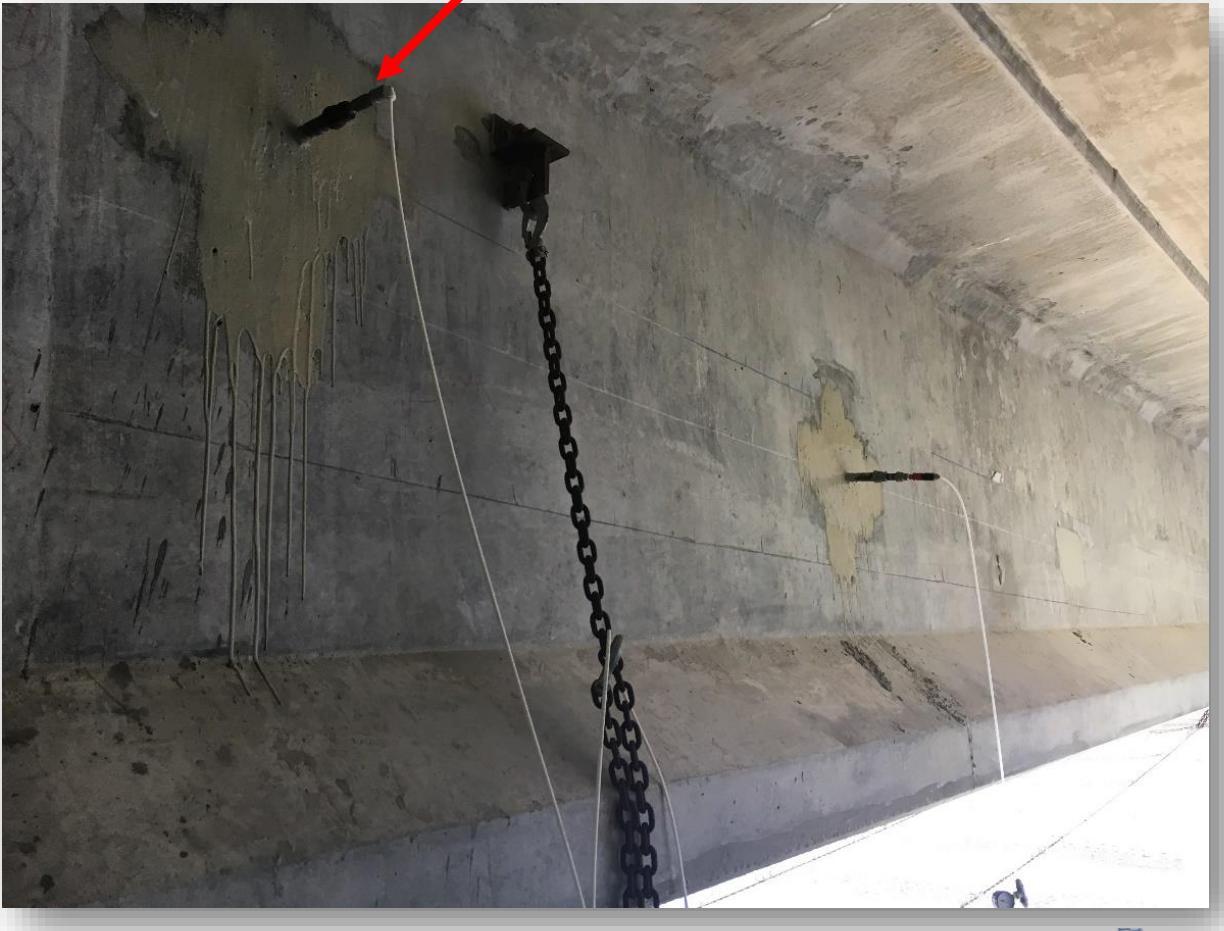
Phase 1 Repair Construction Impregnation process Outlet port

Inlet port

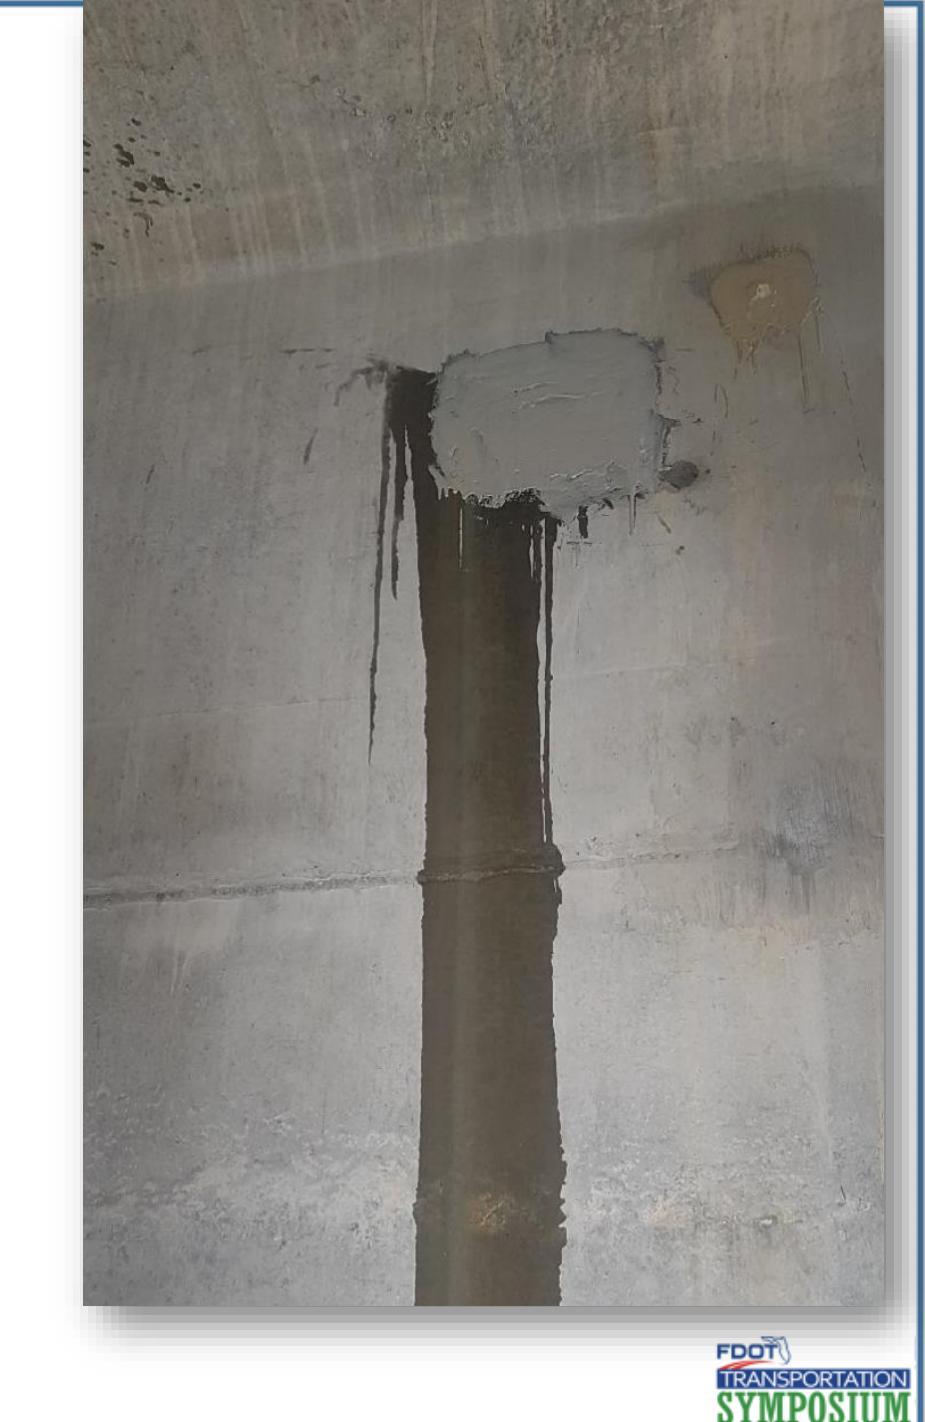
4 Cables Injected
8 cables In progress
(Repairing leak
locations)
